Stream Restoration: Program and Permitting Considerations

Matt Meyers, Chief
Watershed Project Implementation Branch
Department of Public Works and Environmental
Services

Fairfax County, Virginia

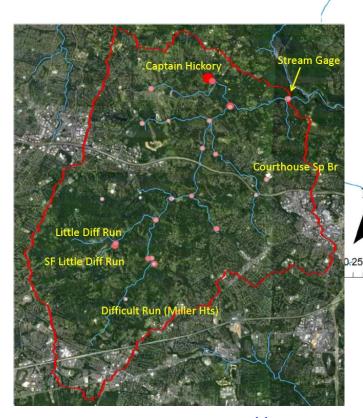
38 Reaches to document channel change

-Each reach 2- 4 cross sections

- 482 pins to quantify bank erosion, bar deposition

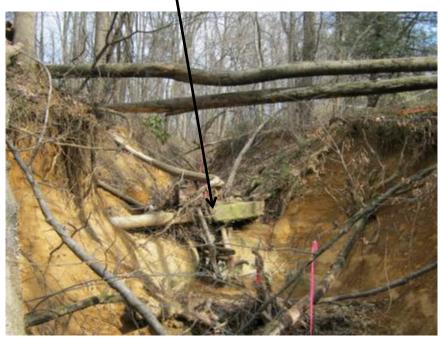
Approximate location of Sanitary Sewer

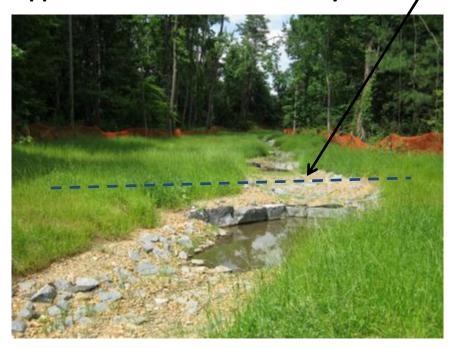
Before: Exposed sanitary sewer line and highly eroded channel.

After: Before trees and shrubs were planted

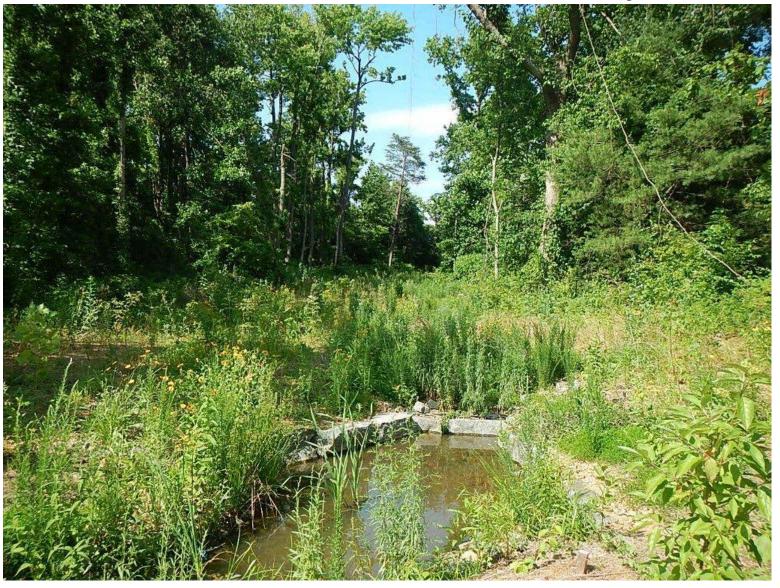
First Spring – June 2013

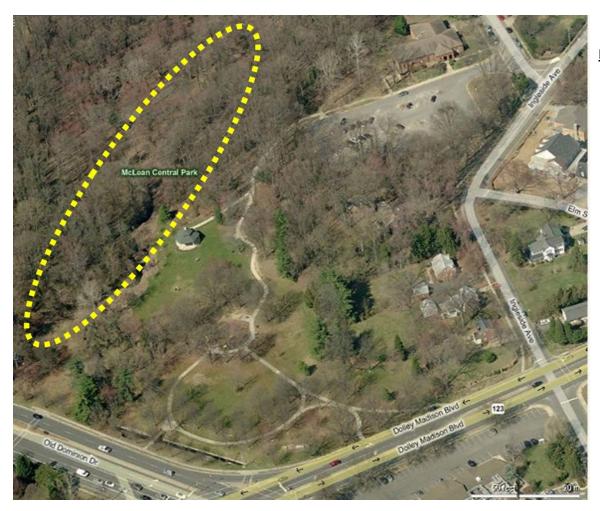
Project Overview:

Approximately 1,400 liner feet of Dead Run stream that runs through McLean Central Park was stabilized with various practices including encapsulated soil lifts, toe protection, stone vanes, compost berms, and fiber log rolls. The stormwater outfall from Dolley Madison library was restored to include a sand filter step-pool system and wetland feature. The entire site was re-vegetated with extensive native plantings of trees, shrubs, grasses and wildflowers. This restoration will substantially mitigate bank erosion and improve water quality.

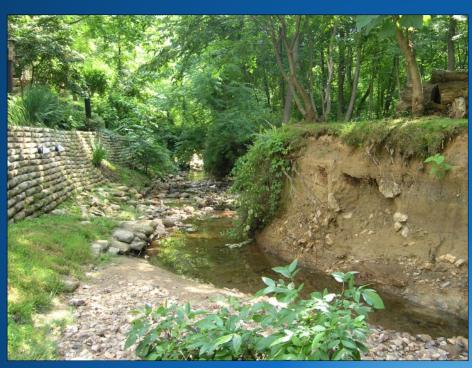
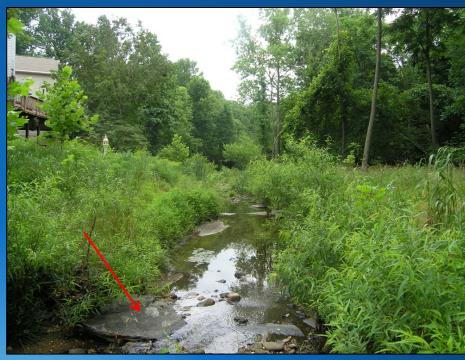
Poplar Springs - Before & After

Drainage Area	Phosphorous Removal	Nitrogen Removal	Sediment Removal
(acres)	(lbs/yr)	(lbs/yr)	(tons/yr)
230.4	7.5	141	1.25
