Applying Principles for the Ecological Restoration of Aquatic Resources to Legacy Sediment Problems in Pennsylvania

Department of Environmental Protection

Pennsylvania Legacy Sediment Workgroup

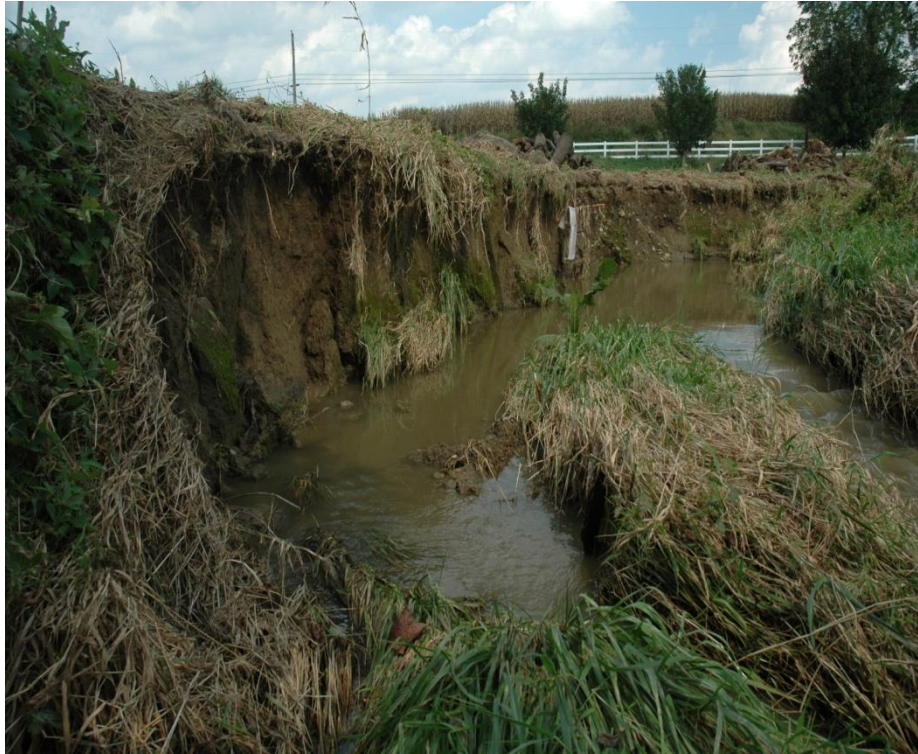
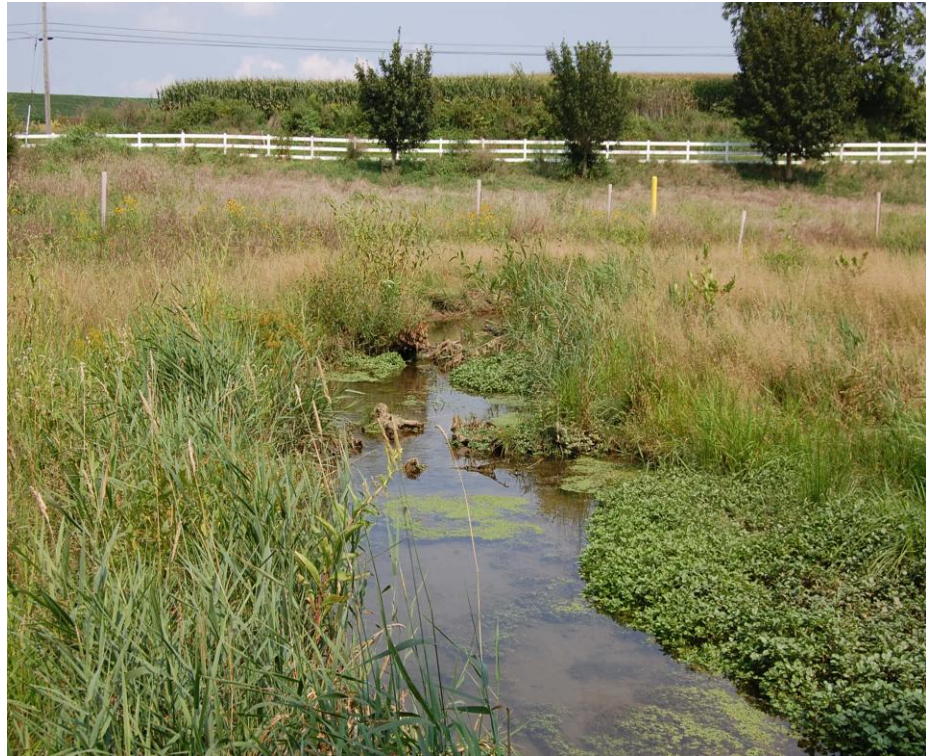
Legacy Sediment Removal

Typical Existing Conditions

Restoration

9/13/2011

08/17/2012

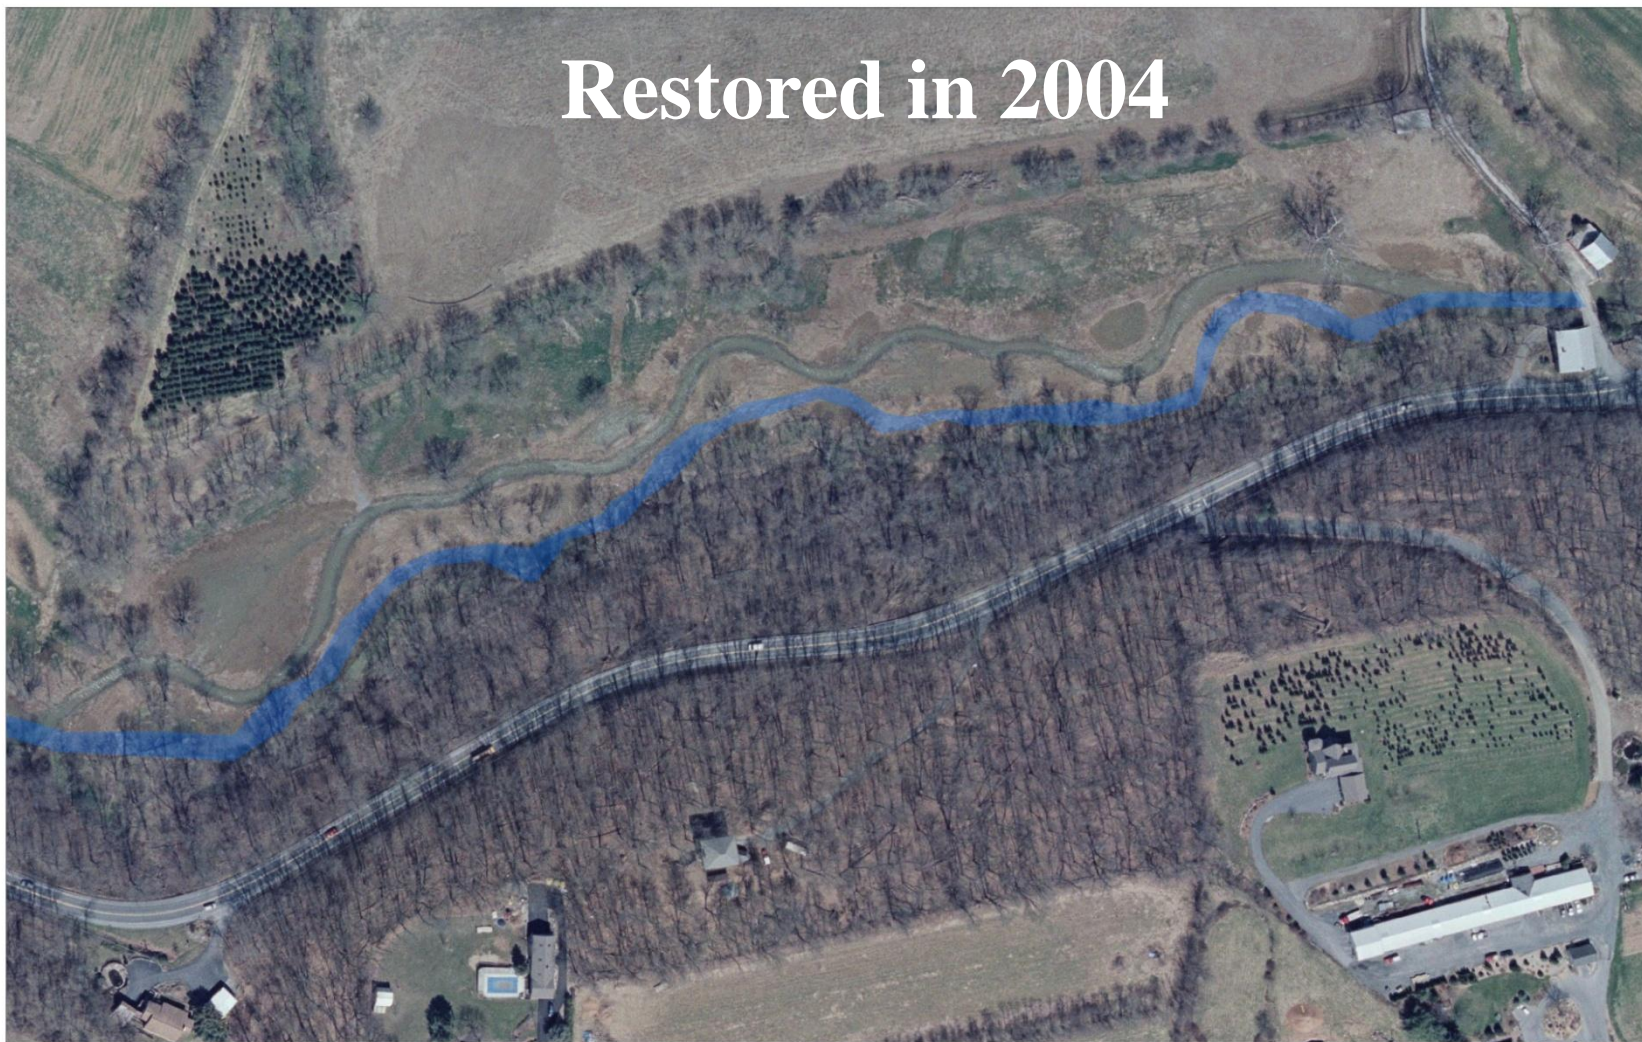
Lititz Run Natural Floodplain, Stream and Riparian Wetland Restoration Project "Banta Restoration Project" - Lancaster County, PA

Restored in 2004

Stream_Channel_Location_Prior_to_Restoration

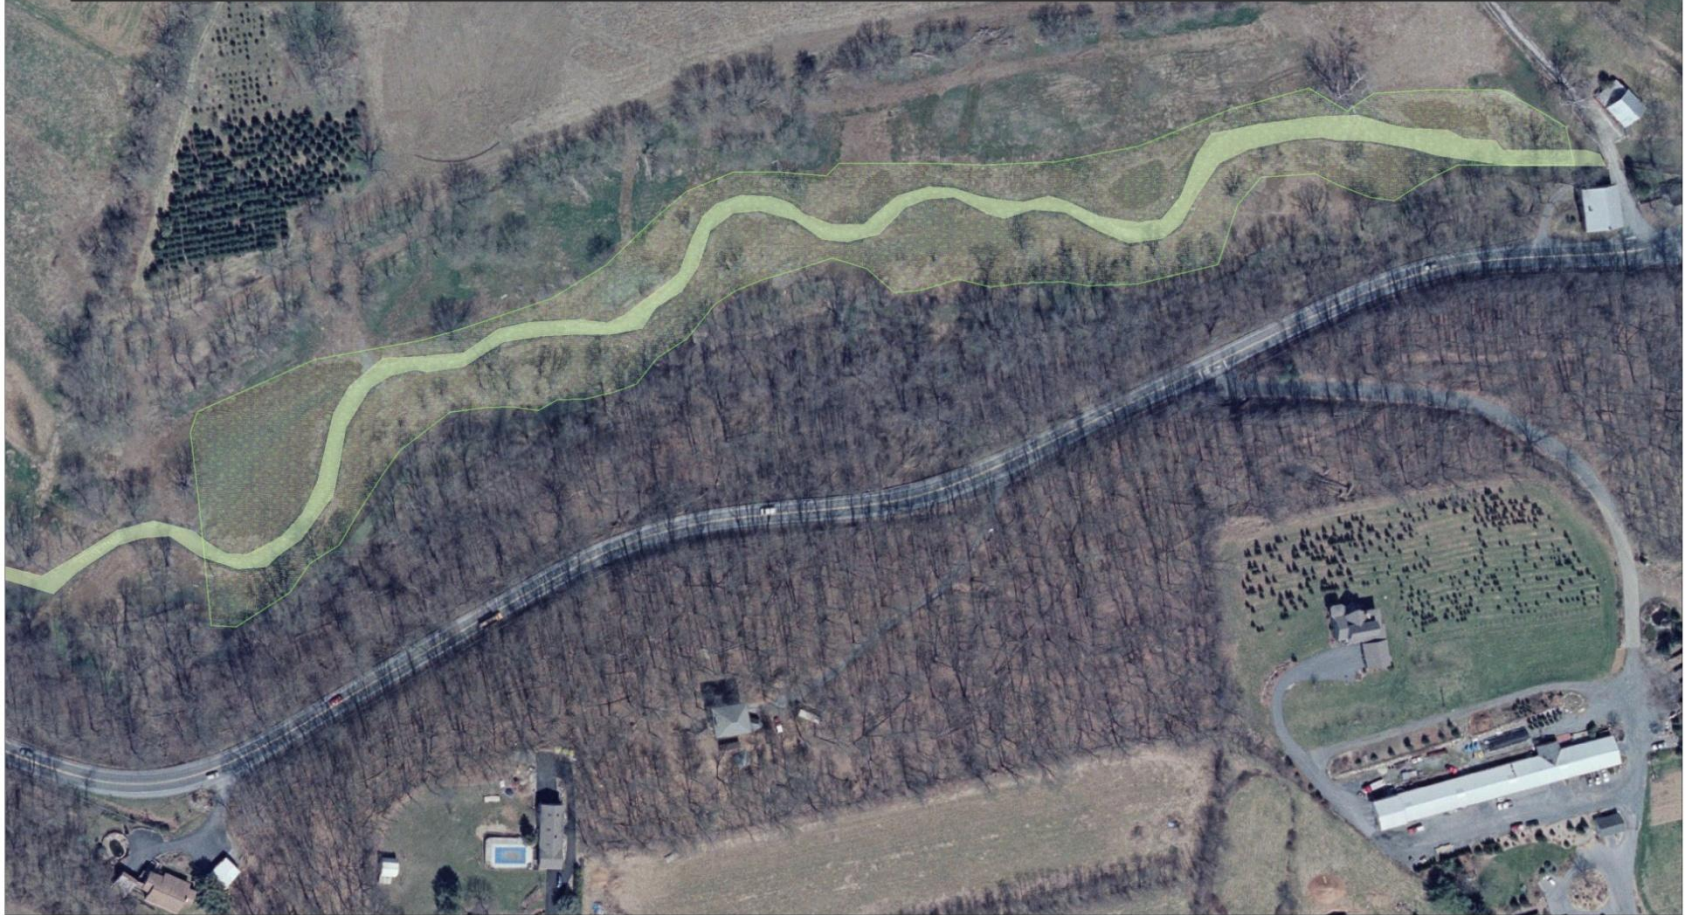
Lititz Run Natural Floodplain, Stream and Riparian Wetland Restoration Project "Banta Restoration Project" - Lancaster County, PA

**Result is ~ 5.6 Acres of Natural Riparian Wetland and Floodplain Restoration
and ~ 2,300 Feet of Natural Stream Restoration**

Stream_Channel_After_Restoration
-

Wetland Restoration - Limits of Legacy Sediment Removal

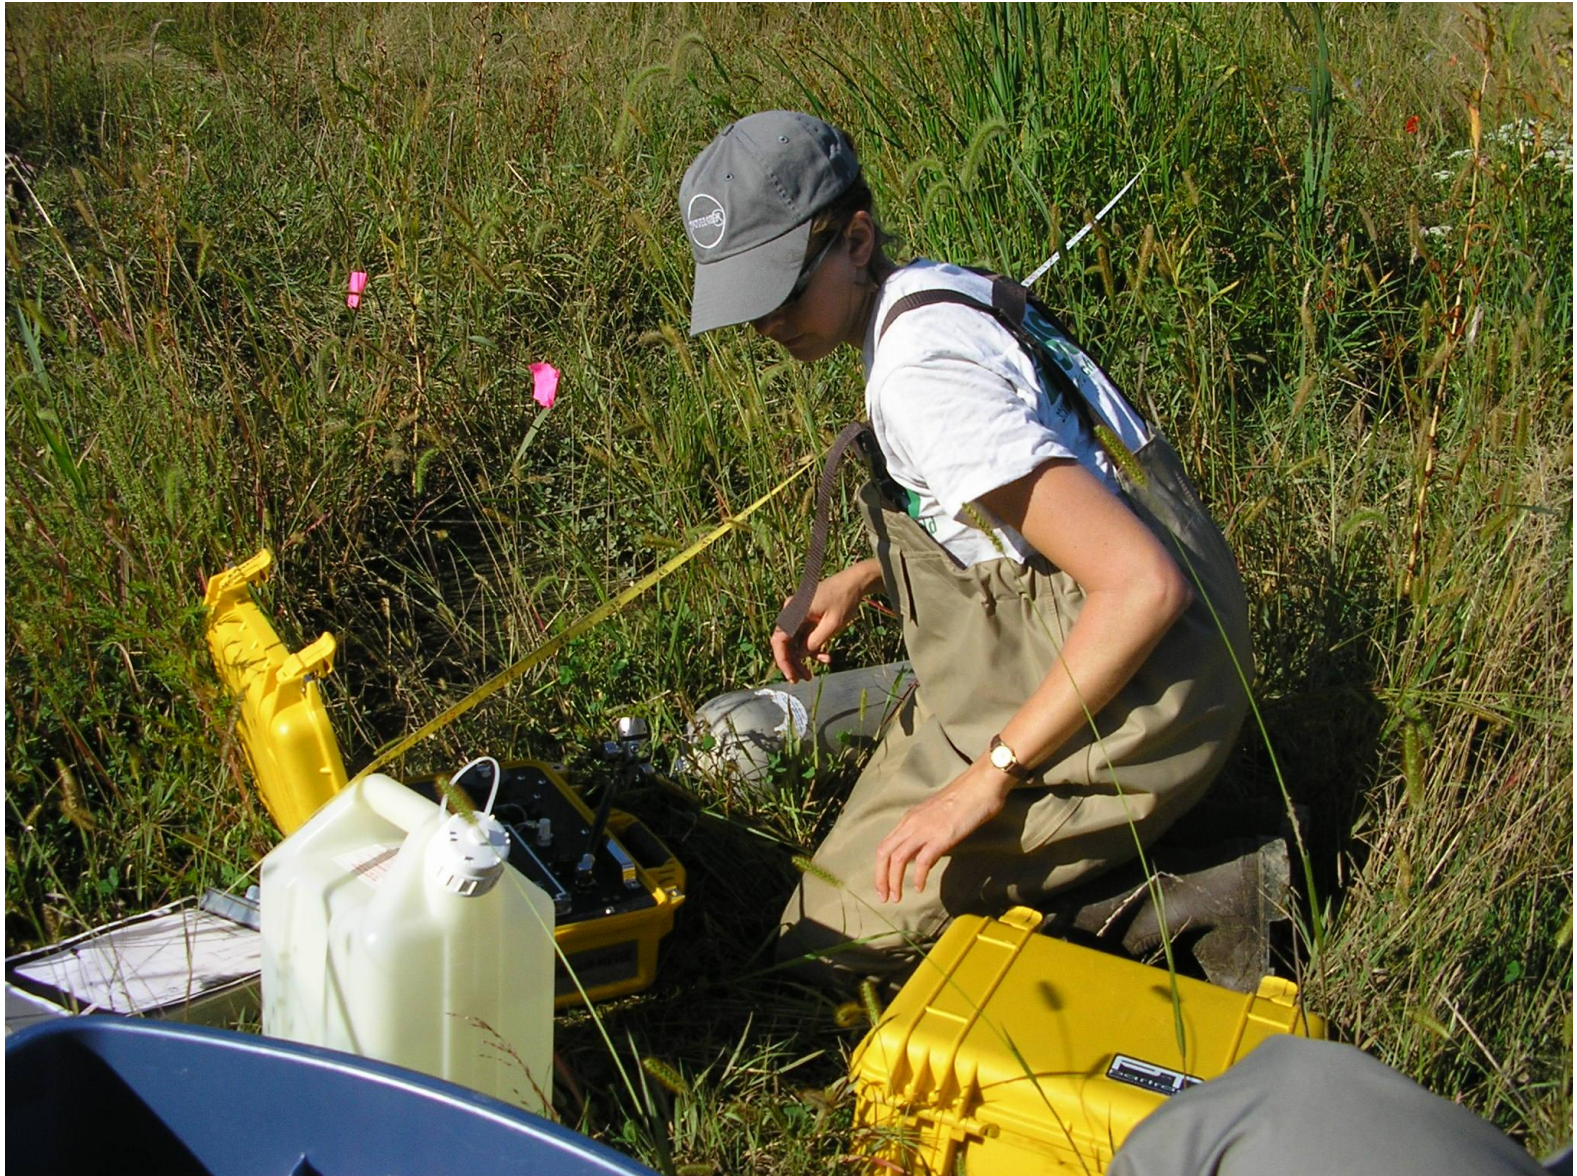
Big Spring Run, Lancaster County PA

Post-Restoration 2012

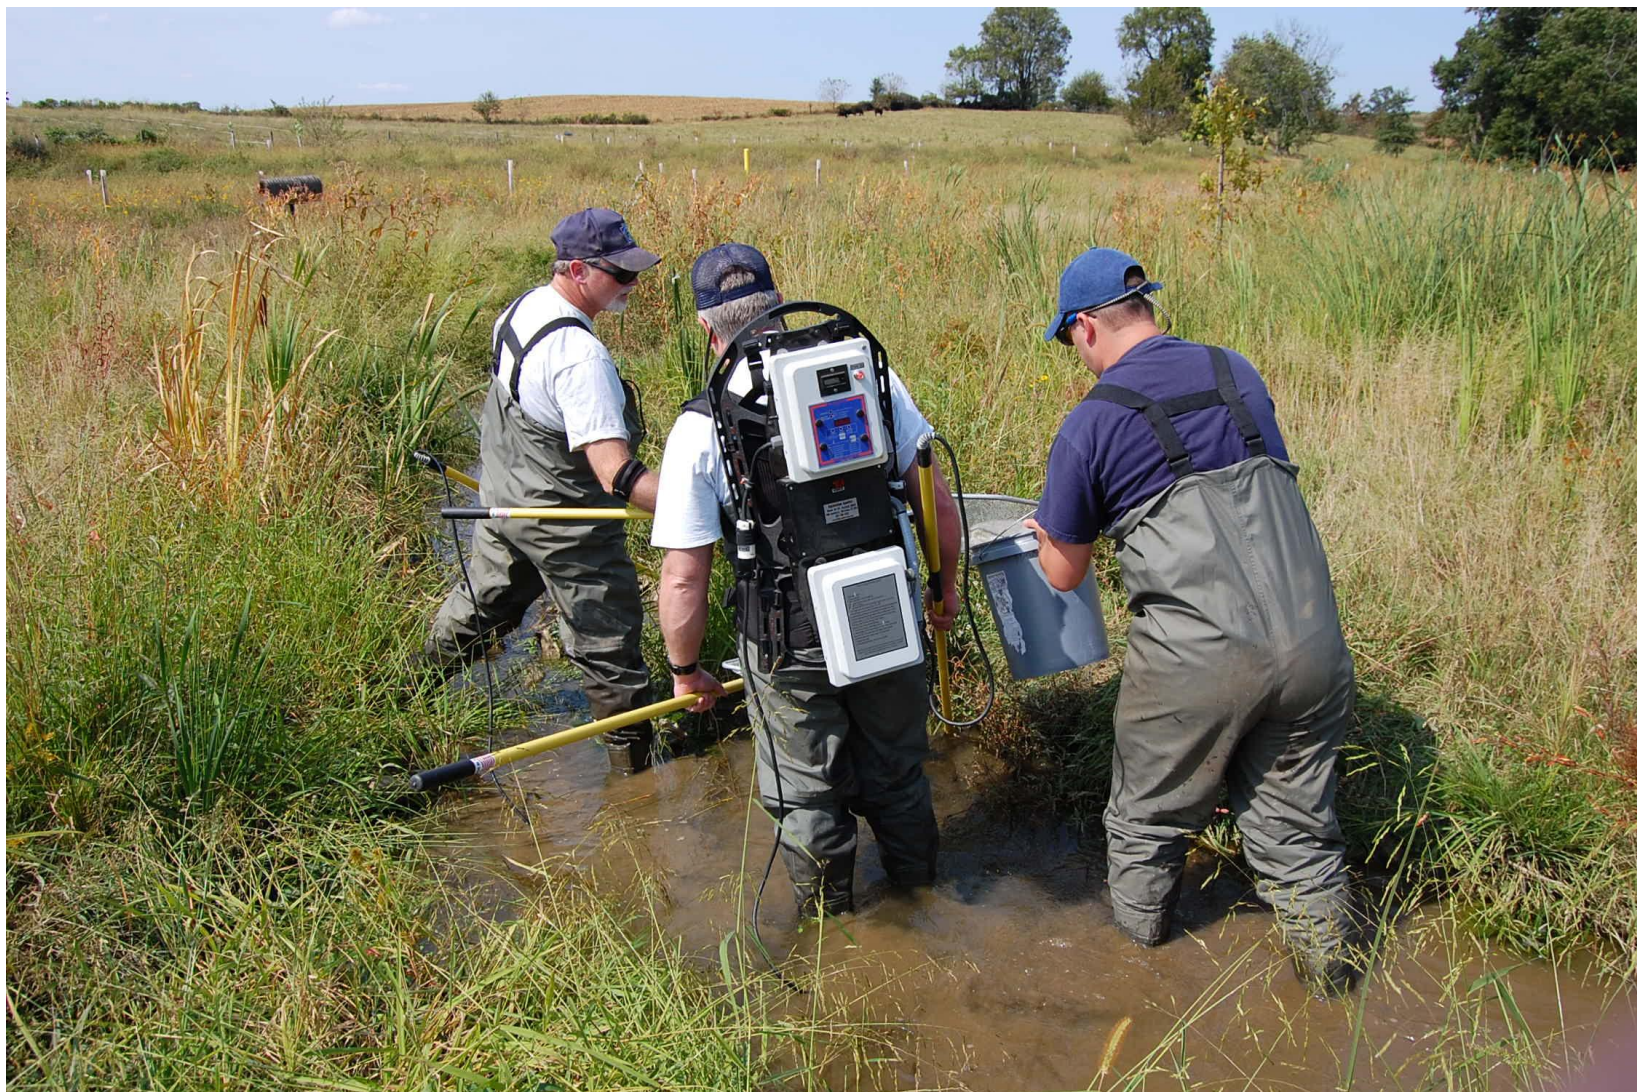
Big Spring Run, Lancaster County PA

Post-Restoration 2012

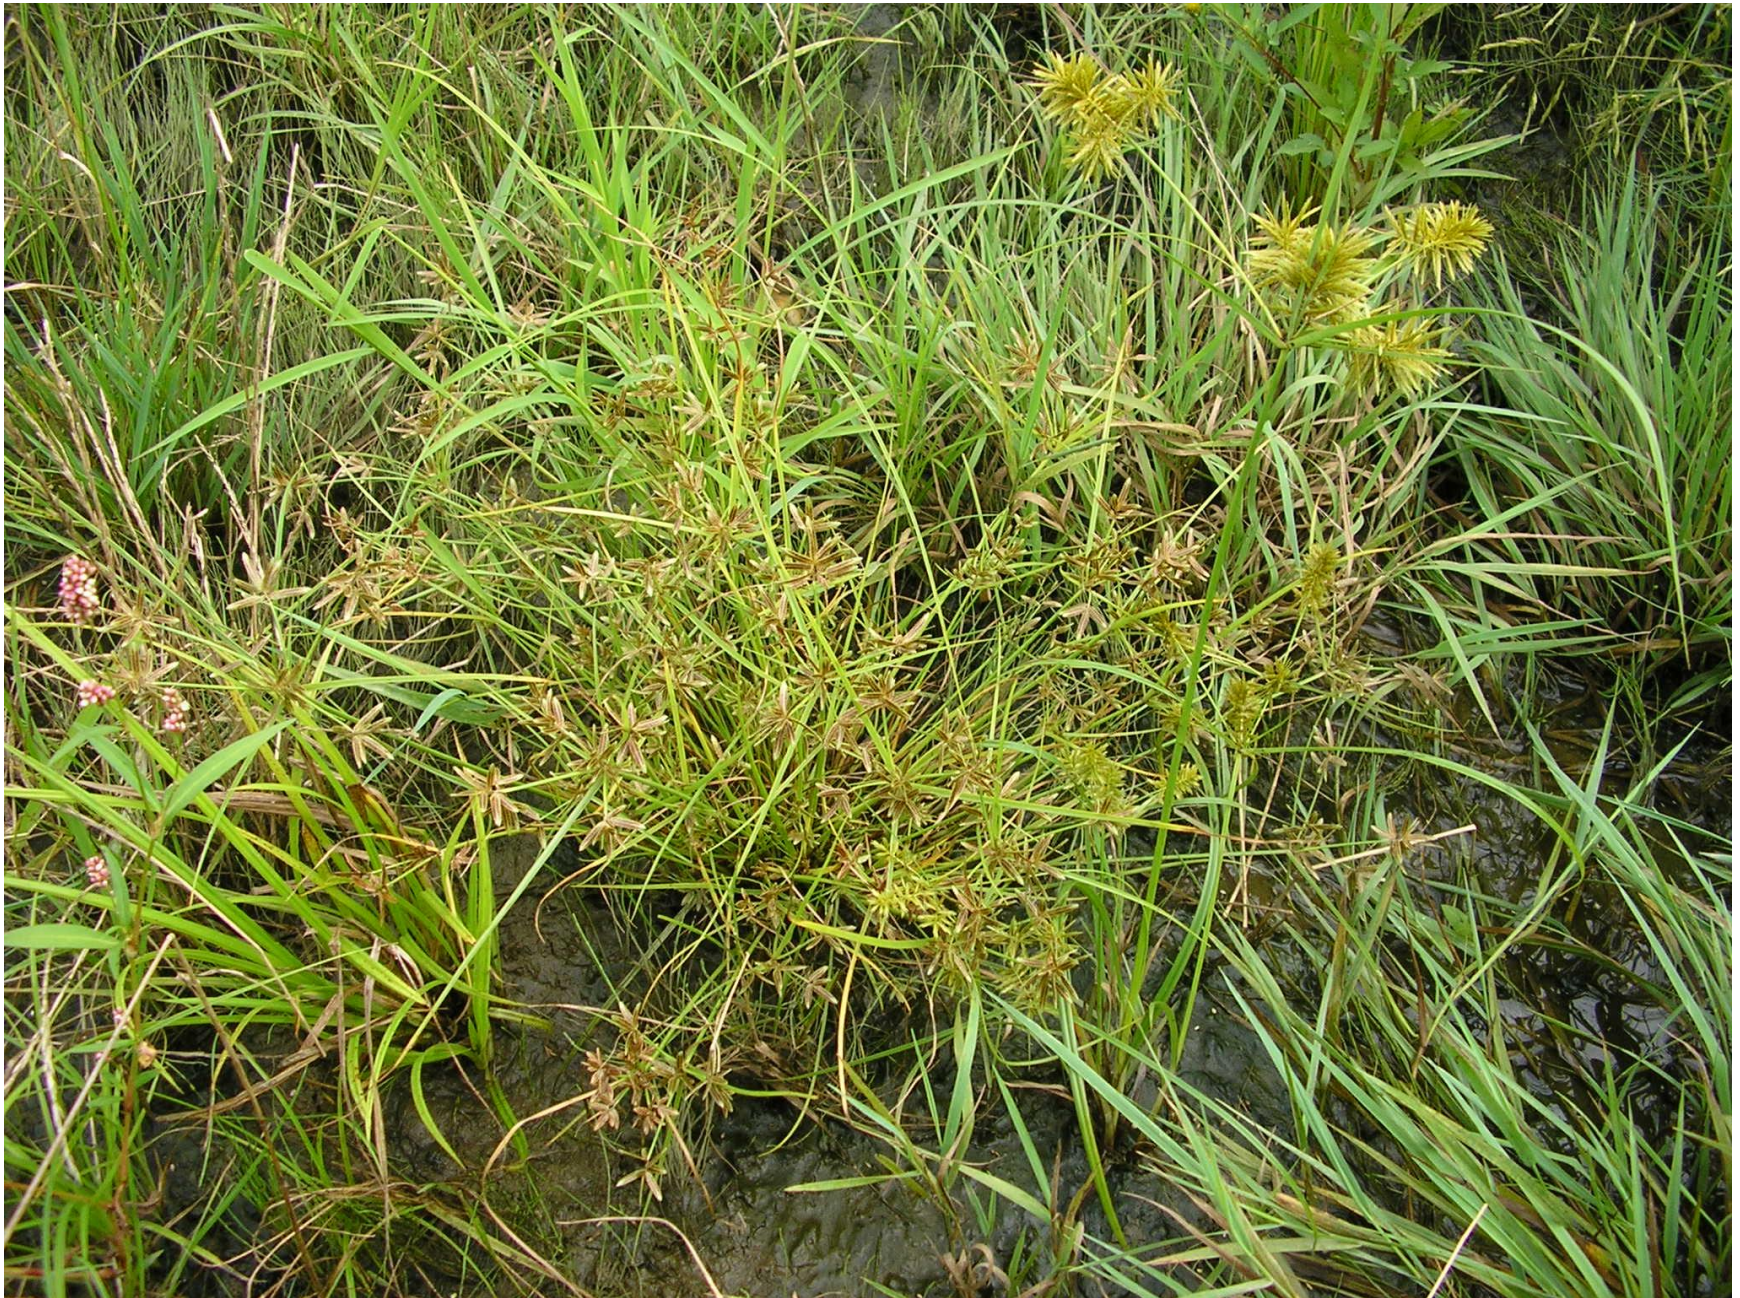
August 2012 – *Cyperus bipartitus*, *Polygonum* spp., etc.
