Banta Site Floodplain Restoration

Rock Lititz - Santo Domingo Floodplain Restoration

Green Master Plan

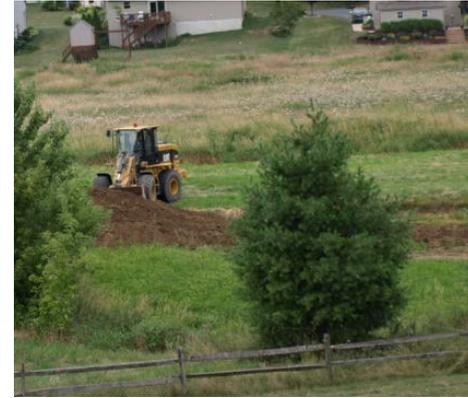
Sediment removal from the forebay of the water quality wetland in 2008.

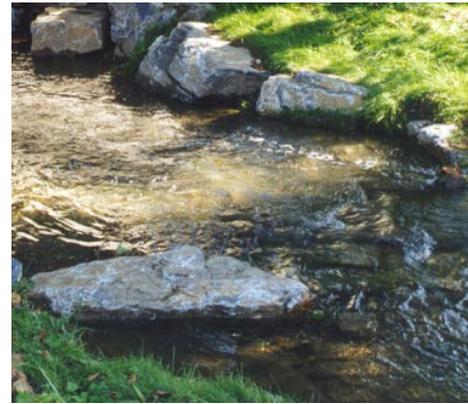
Cross vane stream feature part of the Water Street reach restoration.

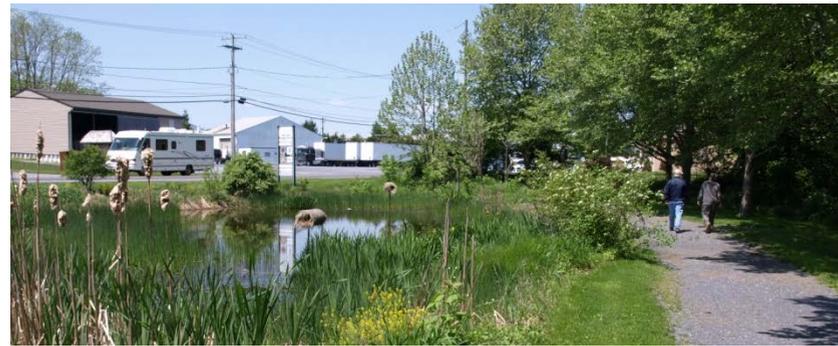
This created wetland, constructed in 1995, continues to provide water quality benefits and a thriving native plant community.

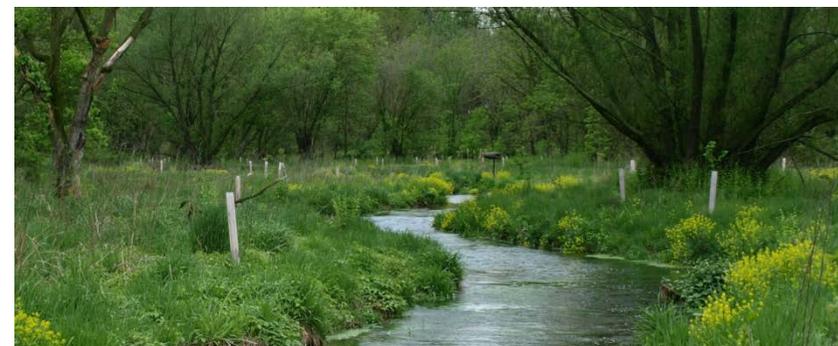
Floodplain restoration constructed in 2005 includes 1,800 linear feet of stream, wetland creation, riparian planting, and significant flood and deposition storage.

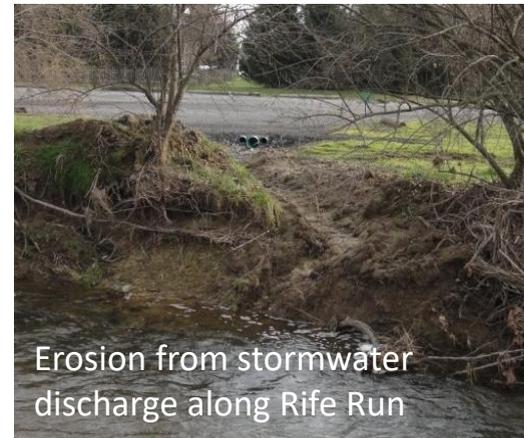
Erosion from stormwater discharge along Rife Run
