Verifying BMPs with High-resolution Land Use Data

PETER CLAGGETT, RESEARCH GEOGRAPHER
U.S. GEOLOGICAL SURVEY

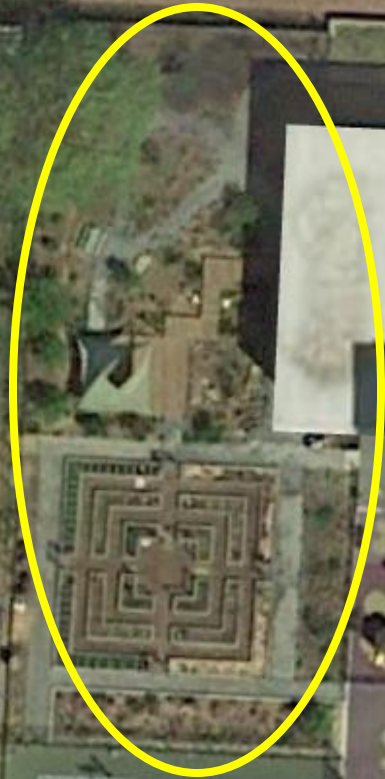
659 G St NE

Impervious Surface Removal (District of Columbia)

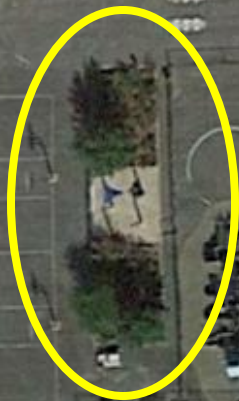
1503 10th St NW

Impervious Surface Removal (District of Columbia)

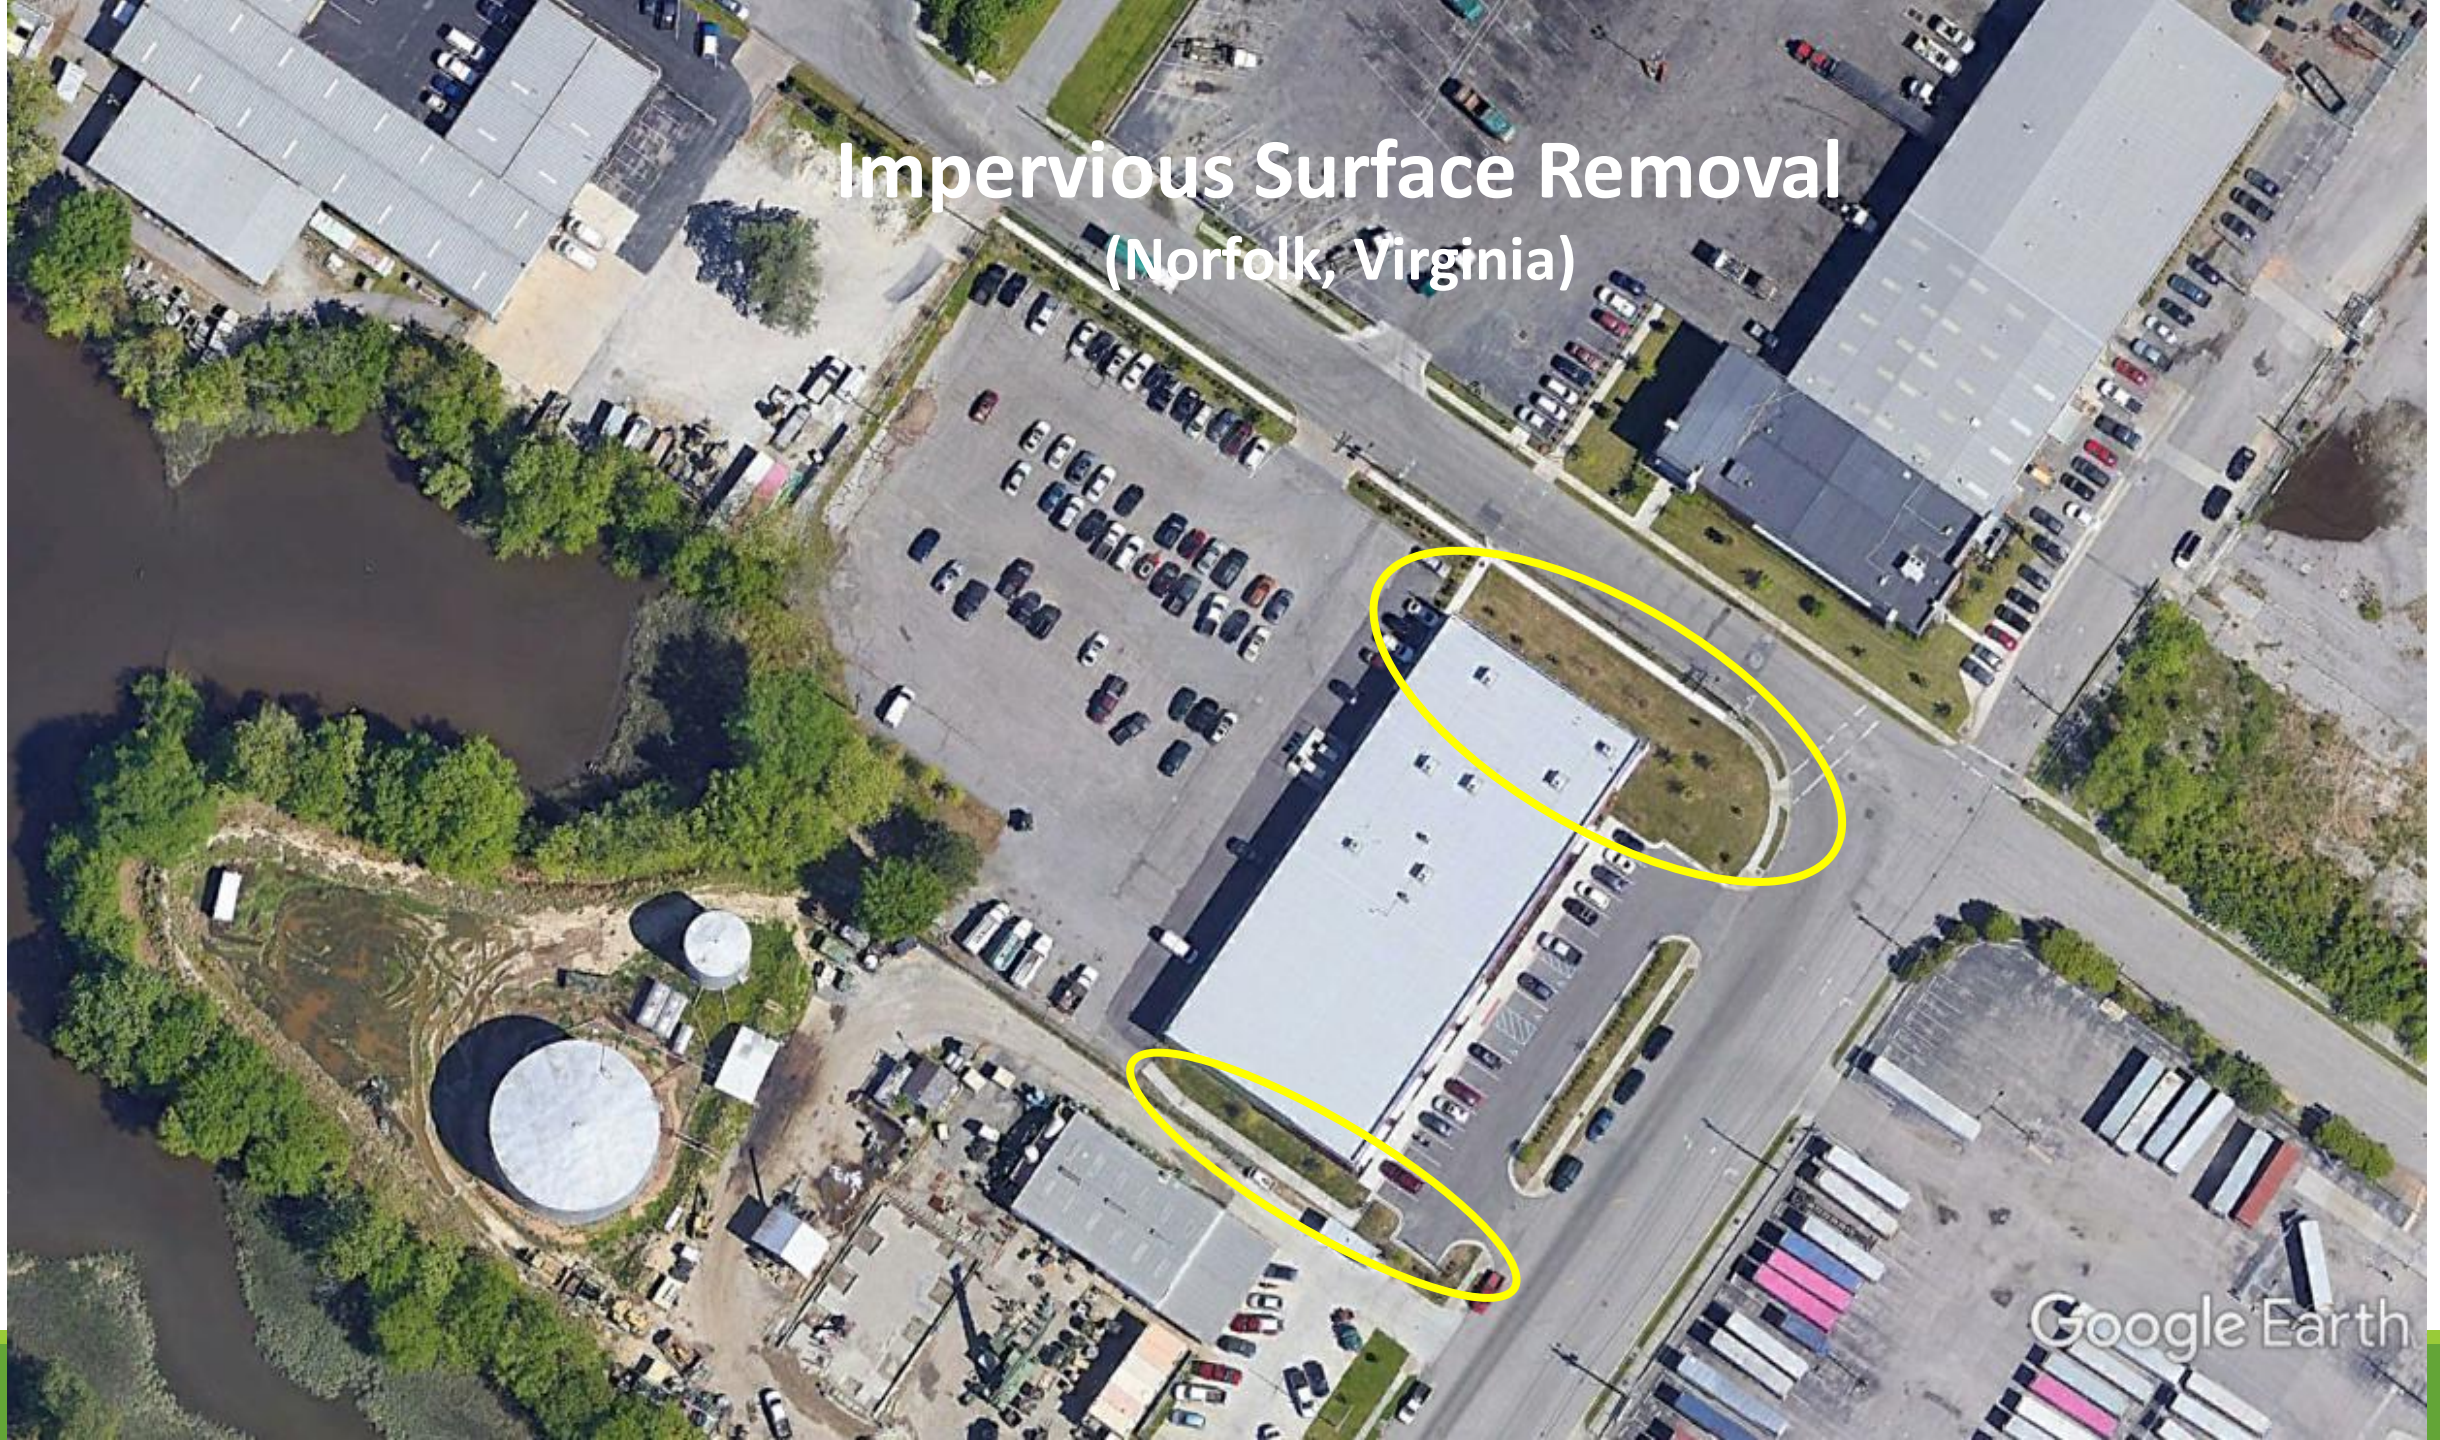
Impervious Surface Removal (Norfolk, Virginia)

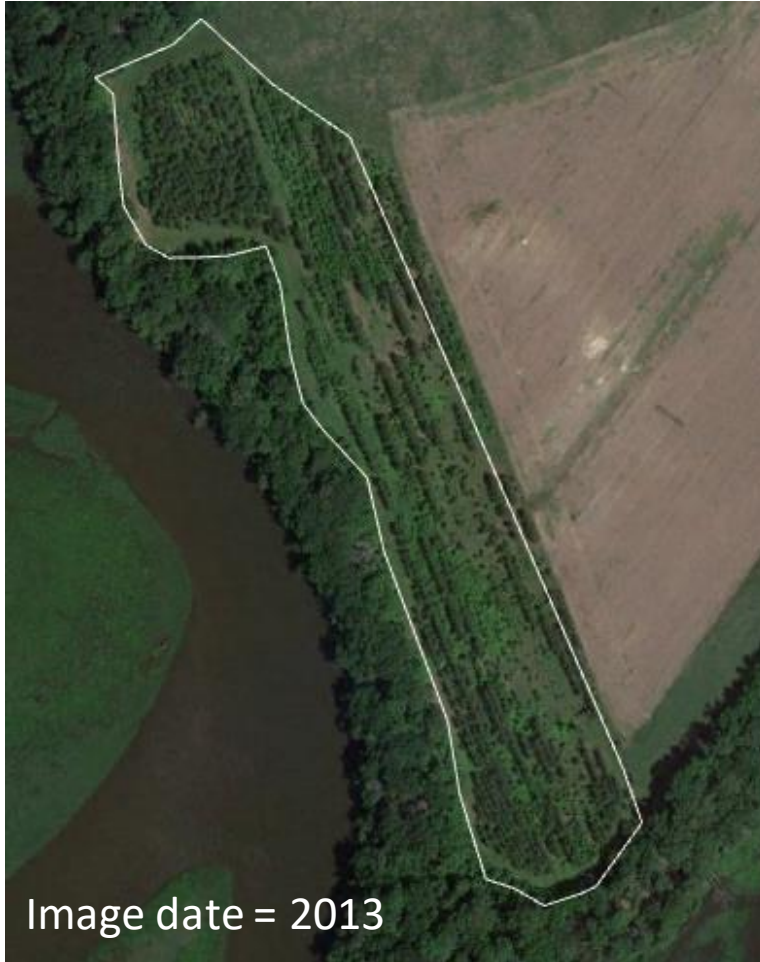
Tree Canopy in 2013 = 6%
Age 10

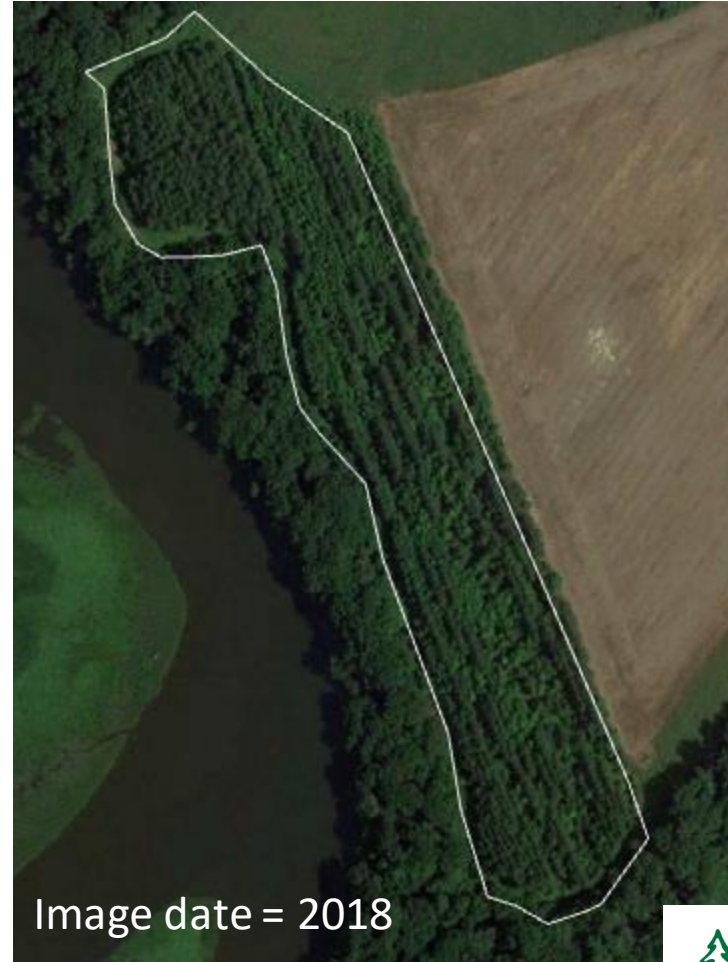
Tree Canopy in 2017 = 98%
Age 14
