# Sediment response of stream restoration practices, Turtle Creek, Union County, Pennsylvania

John Clune, Greg Noe, Matthew Cashman, Jessica DeWitt, Joseph Bell,  
Mitchell Weaver, James Colgin, Tom Doody, Eliza Gross, and Victor Cortes

**Sediment response to stream restoration in an agricultural watershed**

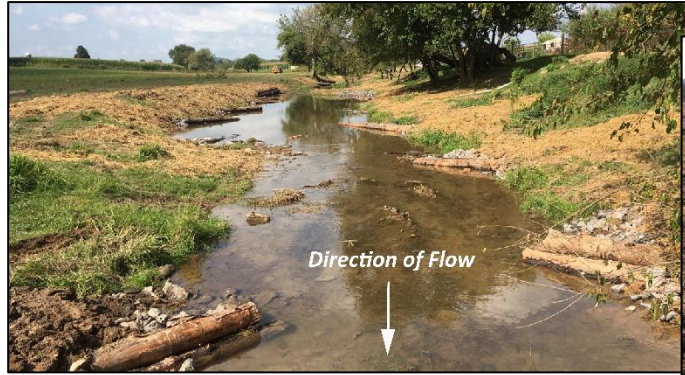
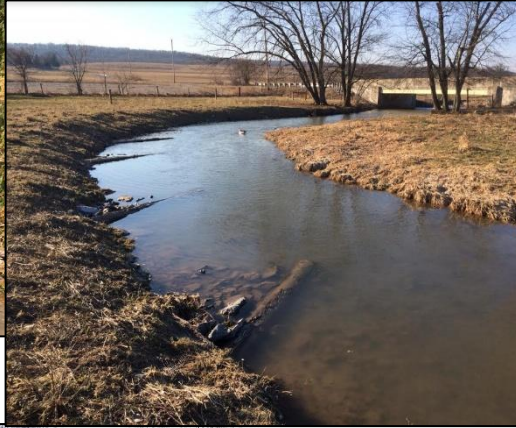
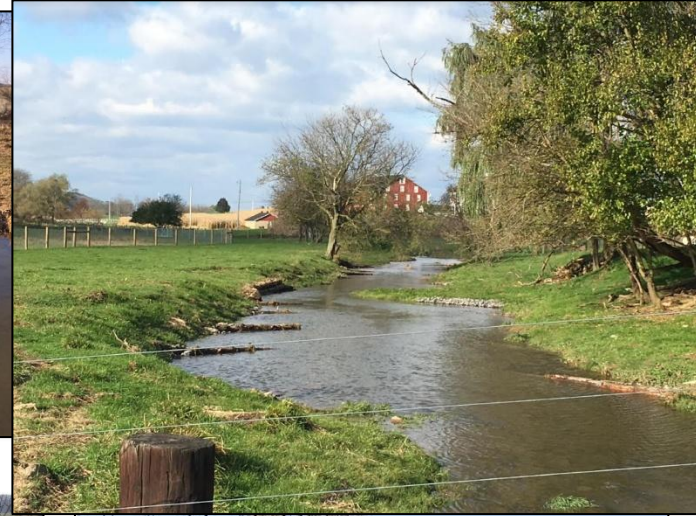
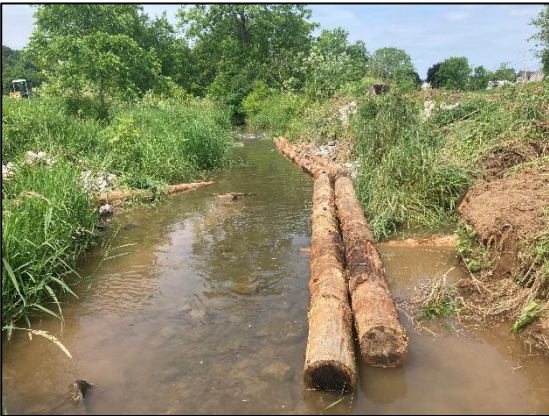
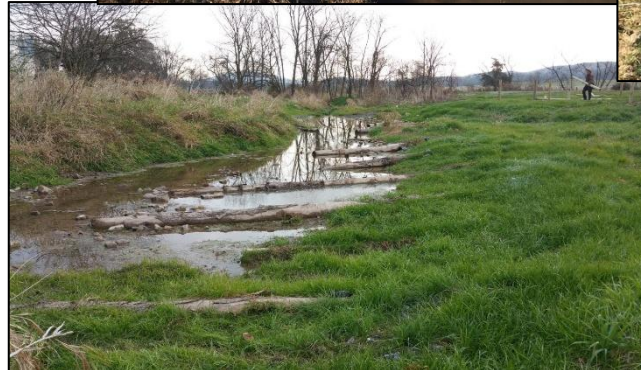
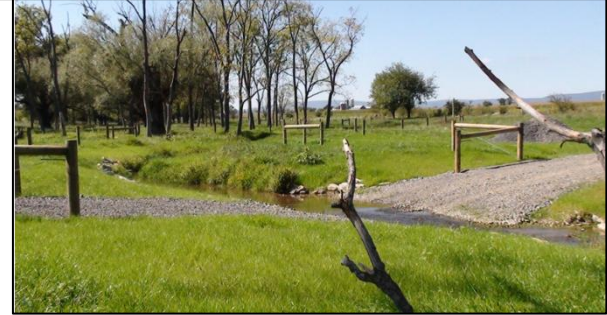
# Turtle Creek restoration: 4+ miles of less intensive, less expensive, holistic restoration

Many log vanes and moundsills and shaved banks, plus stream crossings and fencing, and riparian tree planting

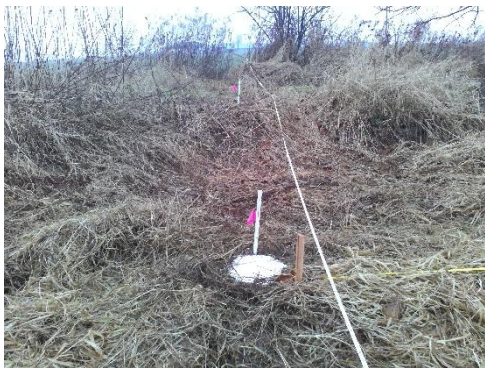
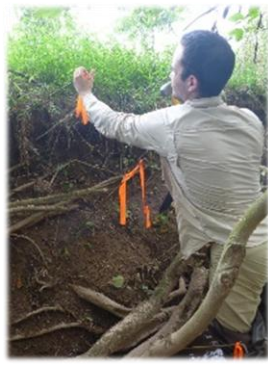
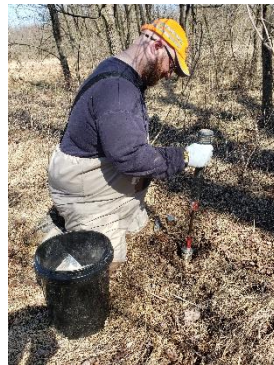
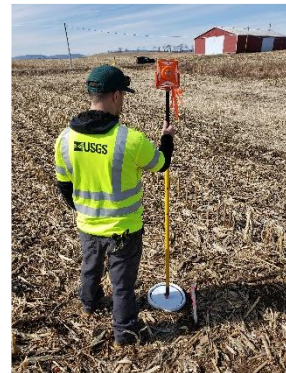
# Measurements of geomorphic change in each stream reach

Restored and unrestored reaches measured for 3 yrs after restorations: 5 x-sections per site.

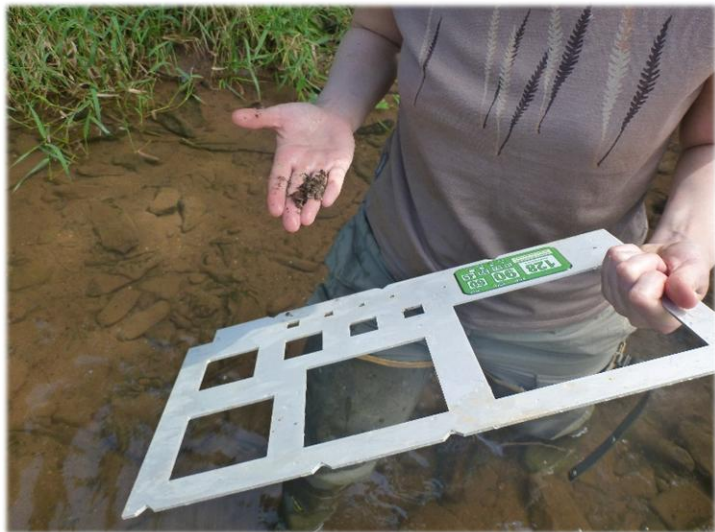
→ Streambed likely coarsened 2X
