CSN TECHNICAL BULLETIN

Bioretention Illustrated:

A Visual Guide for Constructing, Inspecting, Maintaining and Verifying the Bioretention Practice

**Version 2.0
July 30, 2013**

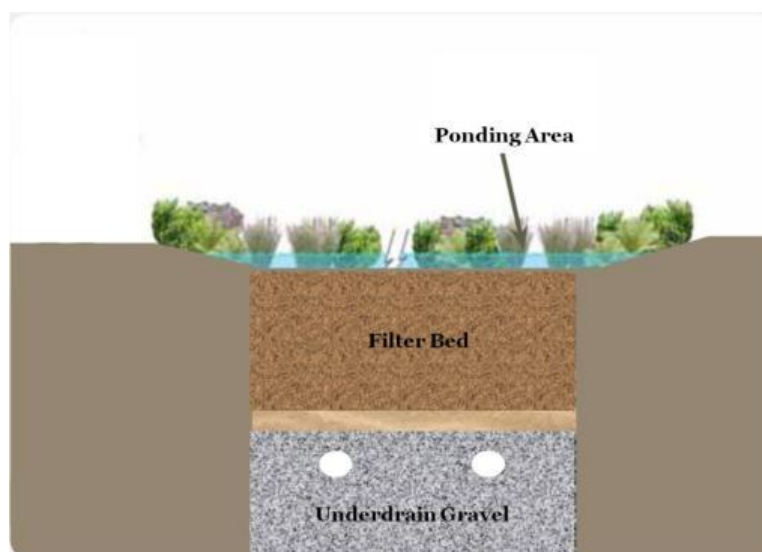
Regardless of the form the bioretention may take, there are several basic design components that are present to ensure the practice's ability to reduce runoff and remove pollutants. These may include: a ponding area, filter bed (or soil media), stone layer (with or without underdrain), an inlet, overflow device or outlet, and vegetative cover (Figure 1).

Figure 1. Bioretention Schematic (WVDEP)

The way a bioretention facility works is that stormwater flows into it and temporarily ponds on the surface in the **ponding area**. Water then slowly filters through the **filter bed** (or media layer) where it may be collected by the **underdrain** (a perforated pipe beneath the filter bed) and conveyed to the storm sewer system. Not all bioretention practices are designed to have an underdrain, in areas of “good” soils (soils that meet a specific infiltration capacity) a practice can be designed to allow the water to infiltrate into the underlying soils.

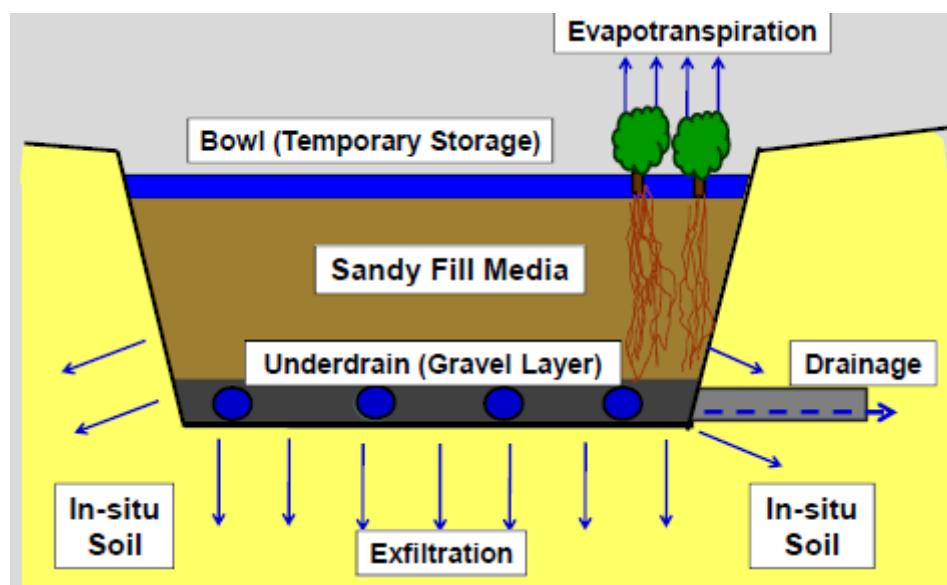
Vegetation is a very important component of a bioretention system. As stormwater makes its way through the practice, it is taken up and utilized by the vegetation along with the corresponding nutrients. Figure 2 demonstrates how runoff makes its way through the bioretention area.

Figure 2. Bioretention Processes (Photo credit: NCSU Stormwater Engineering Group)

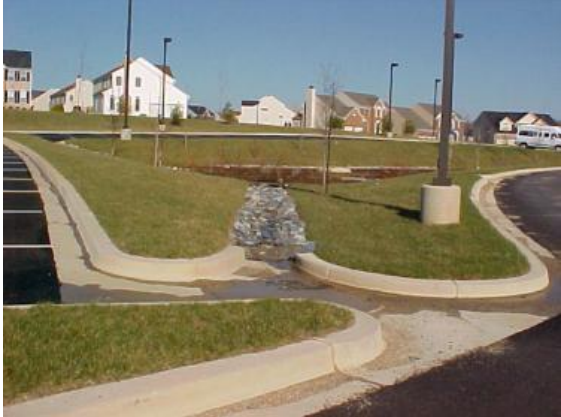
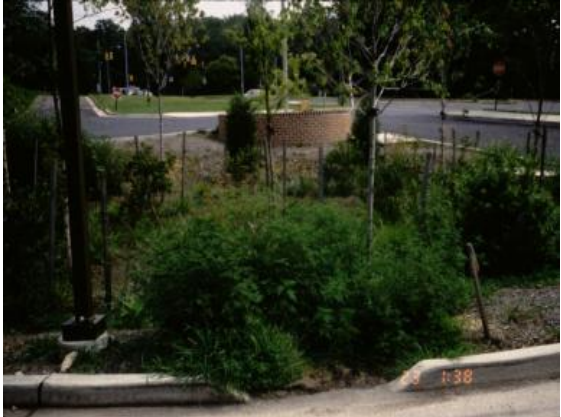
Table 4. Bioretention Inlets

<i>Curb cut – flow enter through defined place in curb</i>	<i>Curb cut</i>

Runoff enters the bioretention area through the **inlet**. Inlets can vary considerably in the way they are designed to function. Table 4 demonstrates the different types of inlets that are often used with bioretention.

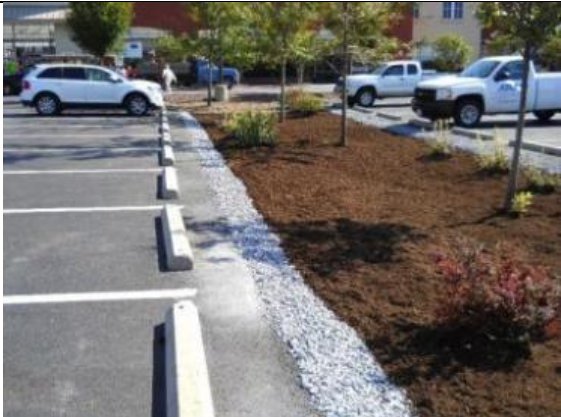
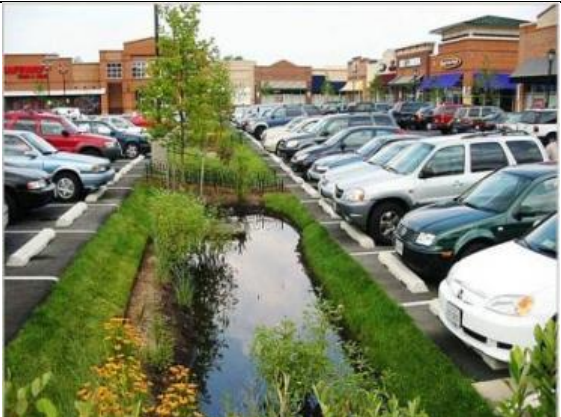
<i>Gravel diaphragm – flow enters as sheetflow and is evenly distributed across length of practice</i>	<i>Grass filter strip: accepts sheet flow from the parking lot</i>

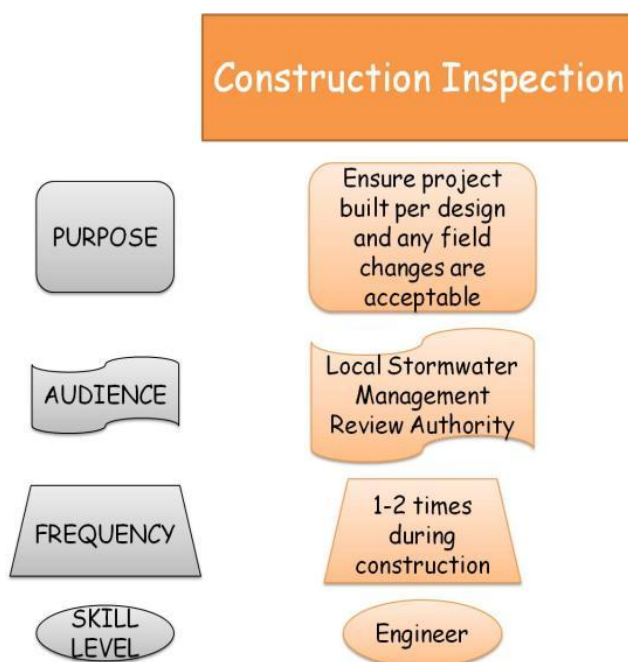
The construction inspection is performed in order to meet requirements for the local stormwater management review authority, and is typically conducted by an engineer or trained stormwater professional at critical points in the construction process. (Figure 3).

Figure 3. The Construction Inspection Process

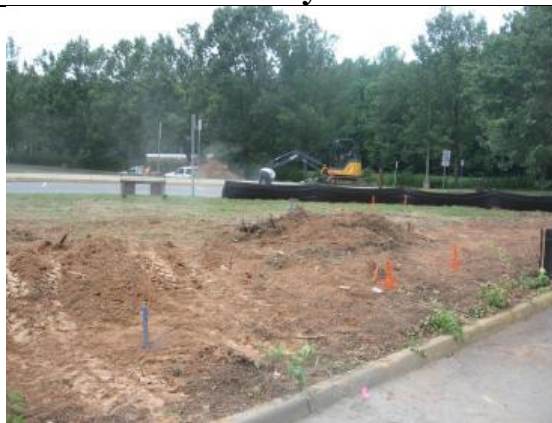
Table 8. A Typical Construction Sequence for a Bioretention Facility	
<p>Step 1. Construction of the bioretention area may only begin after the entire Contributing Drainage Area (CDA) has been stabilized with vegetation.</p> <p>It may be necessary to block certain curb or other inlets while the bioretention area is being constructed. The proposed site should be checked for underground utilities prior to any excavation.</p>

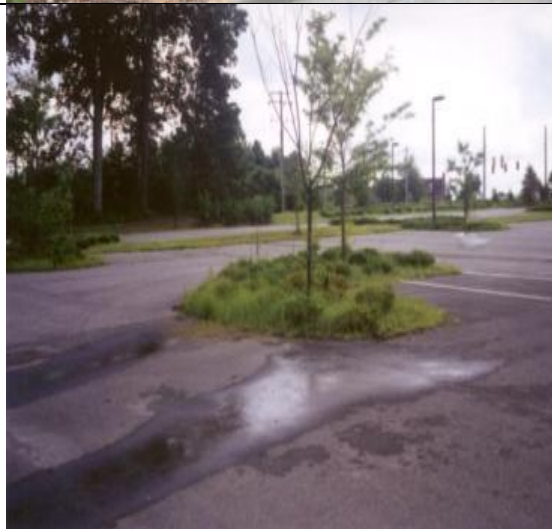
<p>Step 2. The designer and the installer should have a preconstruction meeting, checking the boundaries of the CDA and the actual inlet elevations to ensure they conform to original design. Since other contractors may be responsible for constructing portions of the site, it is quite common to find subtle differences in site grading, drainage and paving elevations that can produce hydraulically important differences for the proposed bioretention area. The designer should clearly communicate, in writing, any project changes determined during the preconstruction meeting to the installer and the plan review/inspection authority.</p>

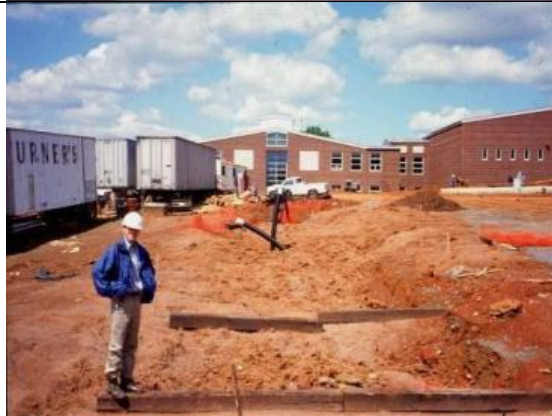
<p>Step 3. Temporary erosion and sediment controls are needed during construction to divert stormwater and sediments away from the bioretention area until it is completed.</p> <p>Special protection measures such as erosion control fabrics may be needed to protect vulnerable side slopes from erosion during the construction process.</p>

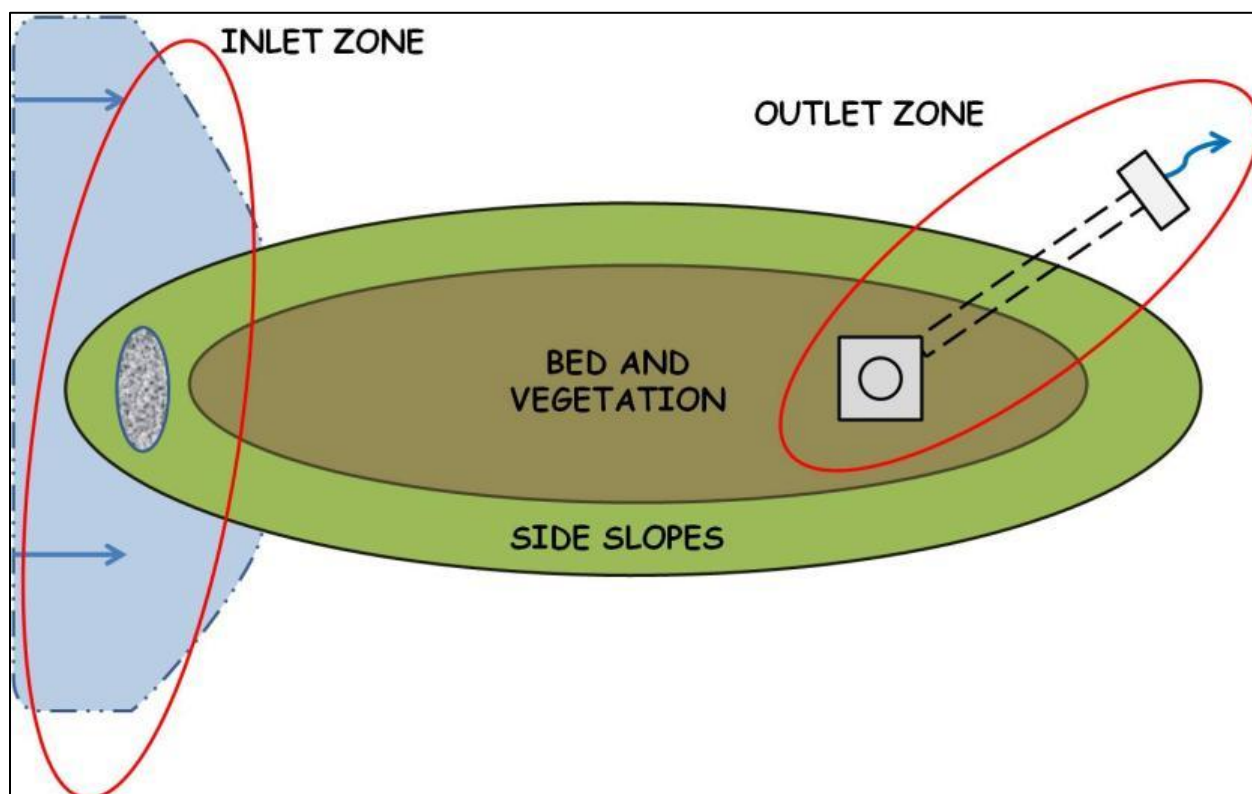
Figure 5 shows where the five different inspection zones are located within a typical bioretention area.

Figure 5. An overhead shot of a typical bioretention area with the inspection zones

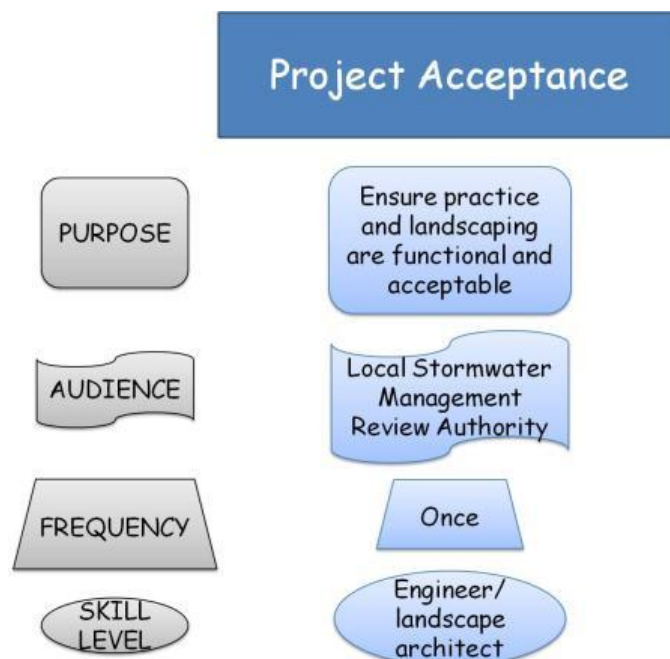
The inspection is normally conducted for the local stormwater management review authority by either an engineer or a landscape architect at the culmination of the construction process, at which time the maintenance responsibility is shifted over to the property owner or responsible maintenance entity (Figure 6).

Figure 6. The Project Acceptance Process

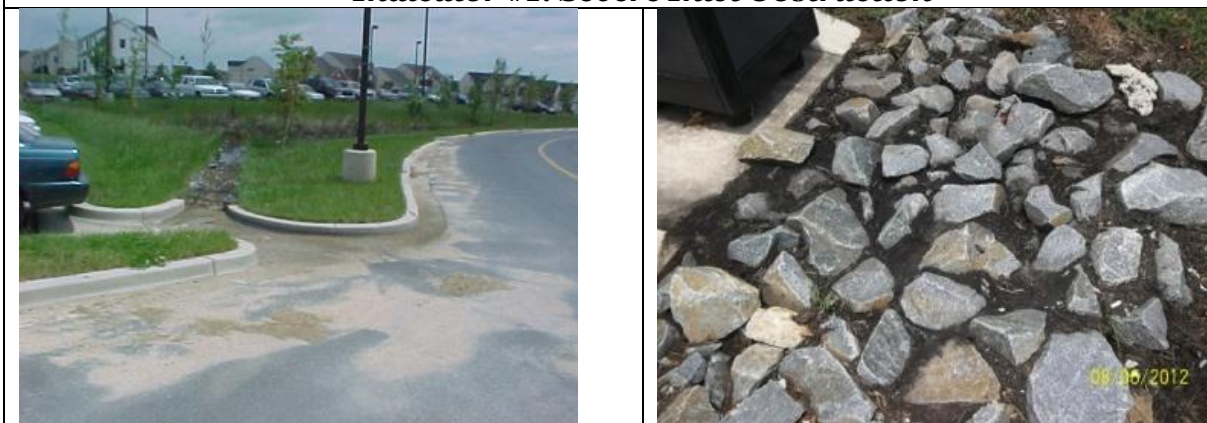
Indicator #1: Severe Inlet Obstruction

Problem: Severe accumulation (greater than 3") of sediment or debris at the inlet so that most of the runoff cannot enter the bioretention facility. Photo on the left shows severe sediment build-up in the crevices between the stones.

Solution: Locate source of the sediment, mitigate and evaluate the need for enhanced pretreatment. Remove riprap, stone, or mulch contaminated with sediment. Clean all sediment from the inflow area. If riprap is used, clean off and replace with original stone, supplemented as needed. If stone or mulch is used, add new material to attain appropriate elevations and flow characteristics. Check inlet elevations and adequate drops from pavement edge to inlet channel. Inlet may need to be reshaped to have adequate drop or slope to filter bed surface so it is not prone to routine clogging. Arrange for more frequent cleaning of sediment from inlet.

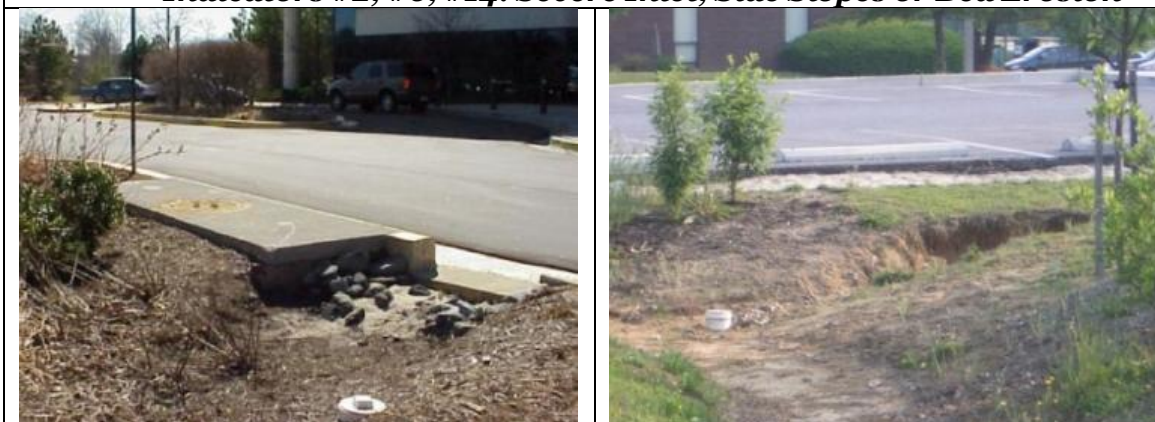
Indicators #2, #6, #14: Severe Inlet, Side Slopes or Bed Erosion

Problem: A foot or more of gully erosion at the inlet or in the bed of the bioretention facility. Greater than 3" of erosion in the side slopes.

Solution: In general, the solution is to determine the cause of the erosion and repair it. This differs depending on where the erosion is occurring. At the inlet, it may be necessary to implement protection measures to ensure that runoff is being dissipated and prevented from entering the facility in a concentrated flow or to extend the protection onto the flat bed area. On the side slopes of the bioretention, it may be necessary to re-grade and evaluate the topsoil and vegetation to determine if there is sufficient vegetative cover to stabilize the slopes. When erosion occurs within the bed of the facility, it is necessary to evaluate the flow patterns and the condition of the bed materials to determine if they are appropriate for the runoff volume. Supplemental protection may be required to match the flow conditions. Soil media should be utilized for any bed repairs to ensure the intended flow characteristics are preserved.

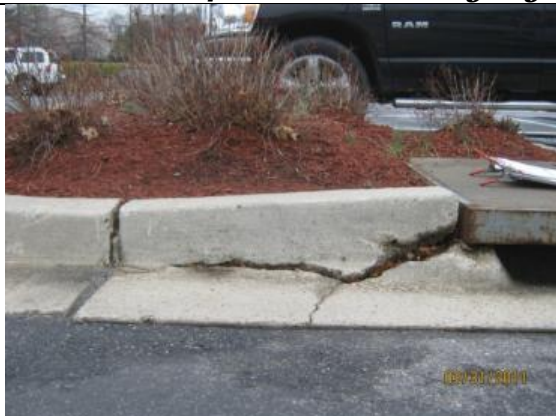
Indicator #4: Structural Integrity

Problem: Curbs, pavement, or drainage structures are damaged to the point where it impairs the function of the bioretention.

Solution: Schedule a visit by a project estimator with relevant project experience to develop a solution and conduct repairs. Depending upon the type of structure involved, such as with a retaining wall, an engineer may need to be consulted to design a solution.

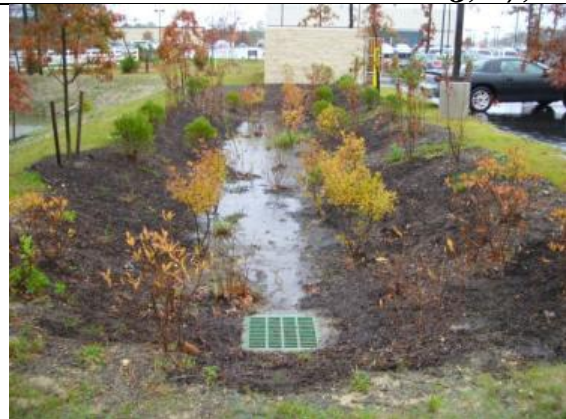
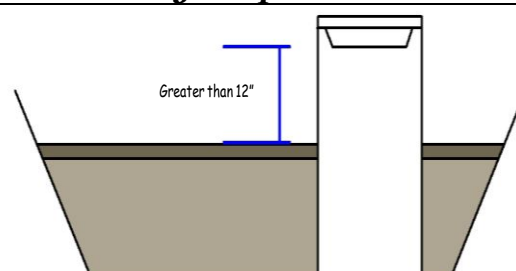
Indicators #5, #7, #11: Severe Design Departures

Problem: A greater than 25% departure from the design assumptions for surface area, storage, ponding depth or contributing drainage area.

Solution: Conduct a topographic survey and consult site plans to determine the cause and degree of the deviation. In the case of ponding depth, adjust grade by removal or addition of mulch and/or media. In the case of surface area and storage, re-grade the facility to meet design areas and volumes. If increasing the surface area, evaluate the dewatering capabilities of the existing soil media area and adjust accordingly. In the case of changes to the drainage area, delineate the actual CDA, re-compute the facility performance, and modify as needed to meet minimum design criteria.

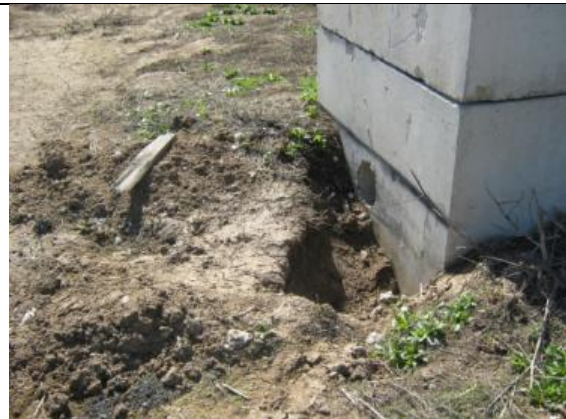
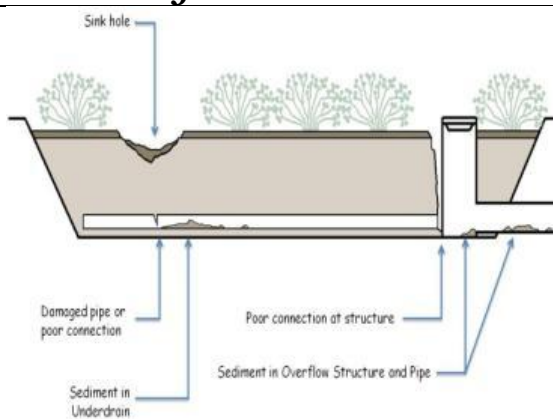
Indicator #8: Bed Sinking

Problem: Greater than 1' of localized bed sinking and/or sediment is observed in the underdrain or overflow. The discovery of sediment in the underdrain or overflow structures indicates the movement of sediment through the facility.

Solution: Severe bed sinking is often a result of breached material layers, poor connections, or damaged pipes within the bioretention facility. Conduct a test pit excavation to provide detailed visual examination of subsurface conditions. Test pitting should occur by hand to minimize compaction of the bed. Make sure dissimilar materials are kept separate and not cross contaminated during the test pitting operation. Be prepared to repair the system (i.e., with new filter cloth or choker stone) to full functionality at test pit completion. Remove mulch, and evaluate the soil media for sediment and/or discoloration throughout the profile. Once through the soil media, cut filter cloth or hardware cloth or, if choker stone is used, remove the next level of stone to gain access to the underdrain stone. Look for voids, loss of material, staining or failure of any of the layers. There should be no evidence of soil media at the underdrain stone layer. If needed, excavate to the underdrain pipe and check pipe and joint condition. All materials should be replaced in appropriate layers to ensure full intended functionality without cross contamination of the individual material layers.

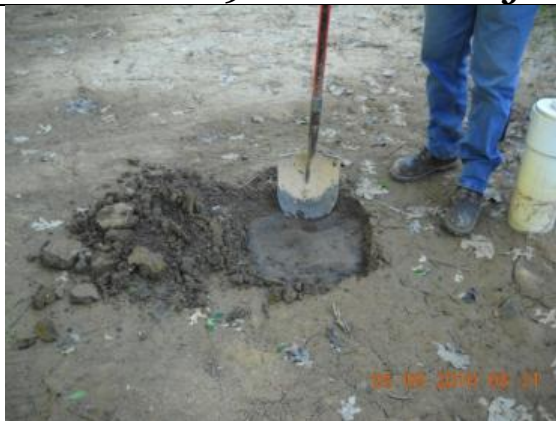
Indicator #9: Sediment Caking

Problem: Greater than 2" of sediment deposition within the bioretention facility or a hard-pan surface due to sediment sealing the surface of the mulch or soil media.

Solution: Sedimentation in the bioretention facility can result from a variety of causes. It can be from a sediment source in the contributing drainage area or from erosion within the facility itself. Conduct a full cleanout of sediment, mulch and soil media in the affected area to depth of 6" within the bed surface or to the point where sediment is no longer observed in the soil media. Identify source of sediment and work to remediate it.

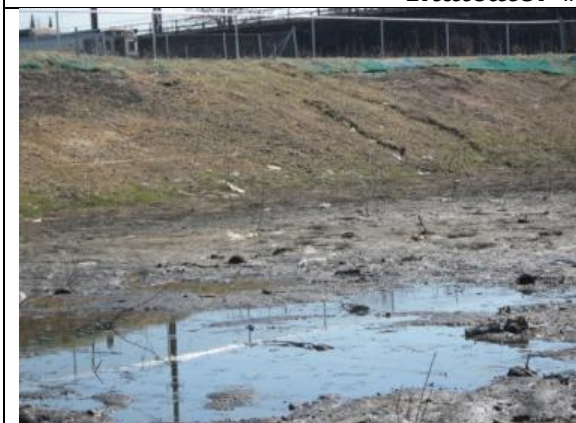
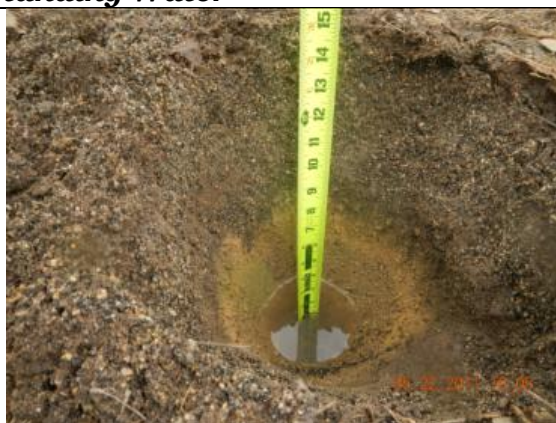
Indicator #10: Standing Water

Problem: Standing water in the bioretention facility 24-48 hours after a design storm indicates the facility is not functioning as designed.

Solution: Confirm that the underdrain pipe is perforated and not blocked. Pump down the water and conduct a test pit excavation (as described in Indicator #8) to investigate the mulch, soil media and possible presence of filter cloth (which should NOT be used as a separation barrier between the soil media and underlying underdrain stone layer). All pumping should be discharged through a geotextile bag. Evaluate the condition of the materials and look for signs of sediment and saturation in the soil media profile. First, determine if sediment is clogging the surface of the mulch or soil media. Then determine if the soil media contains too many fines with either a simple field test or laboratory analysis. If filter cloth is present, determine if it is functional and of the correct specification (non-woven geotextile fabric with a flow rate of > 110 gal./min./sq. ft.). If choker stone is present, determine if the in-place stone matches the specification (typically #8 or #89 washed gravel).

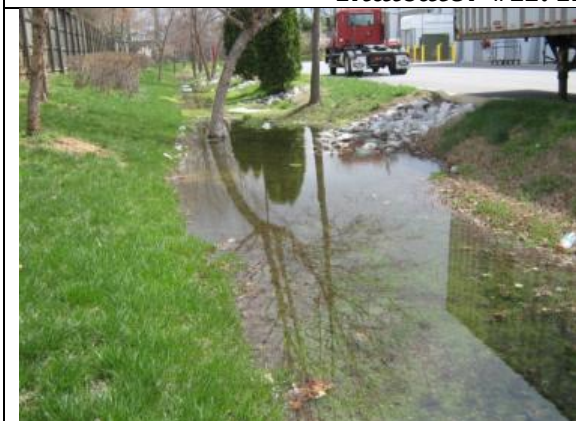
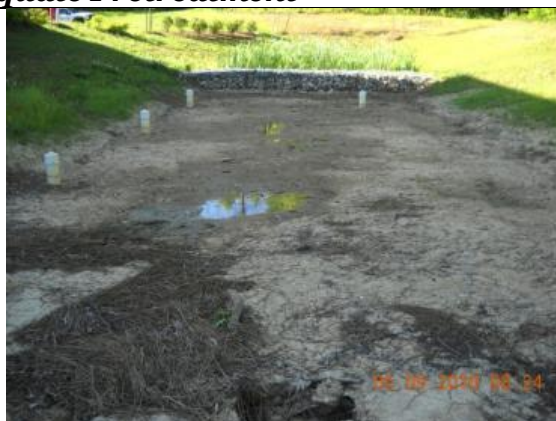
Indicator #11: Inadequate Pretreatment

Problem: Severe accumulation of sand or sediment within the bioretention facility or the pretreatment area. Evidence of standing water in the pretreatment area or bypass of the bioretention facility altogether.

Solution: Locate the source of the sediment, mitigate and evaluate the need for enhanced pretreatment, corrected or more frequent maintenance, and/or design remediation. In many cases, ensuring that maintenance personnel are removing minor amounts of sediment while performing routine maintenance can help correct the lack of pretreatment.

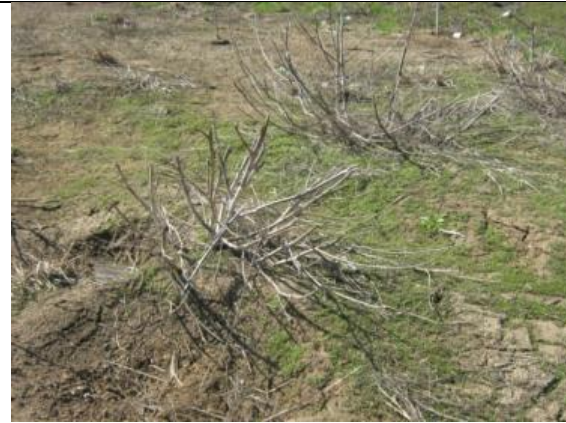
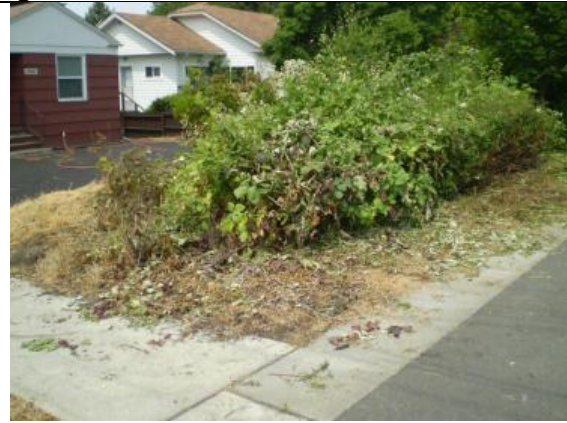
Indicator #14: Vegetative Cover

Problem: When the bioretention facility suffers from less than 35% vegetative coverage, dead or diseased plants or overgrown with invasive species.

Solution: Evaluate the cause of the plant failure (soils, species, disease, design) and create a new planting plan based on the outcomes of those findings. The analysis of the plant material should include a soil test to determine if critical parameters, such as pH, organic matter, and moisture are a match for the intended species. For invasive species control, design and implement an eradication plan. Following the remediation, ensure that appropriate plant maintenance, such as mulching, fertilizing, weeding, disease intervention, etc. occurs to avoid a re-occurrence of the failure.

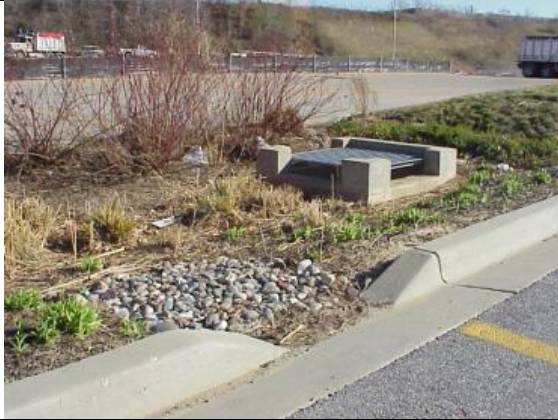
PASS

This inlet is clean and in good condition.

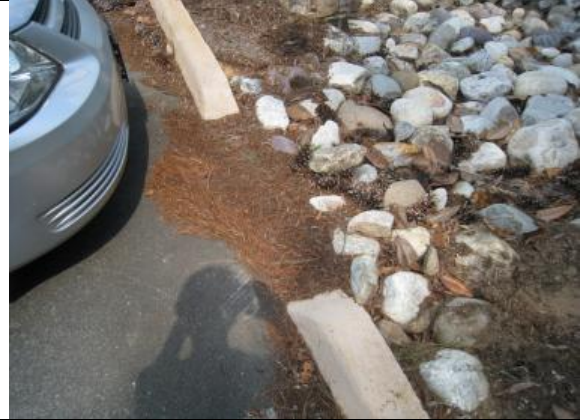
MINOR

There is a minor amount of sediment and/or debris build up at the inlet.

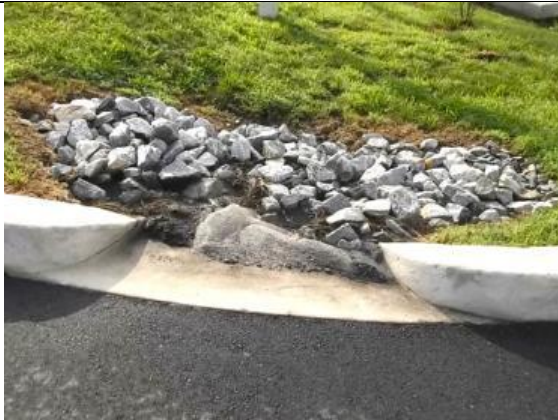
MODERATE

The moderate amount of sediment accumulation at this inlet indicates an entry problem that could lead to a risk of blockage.

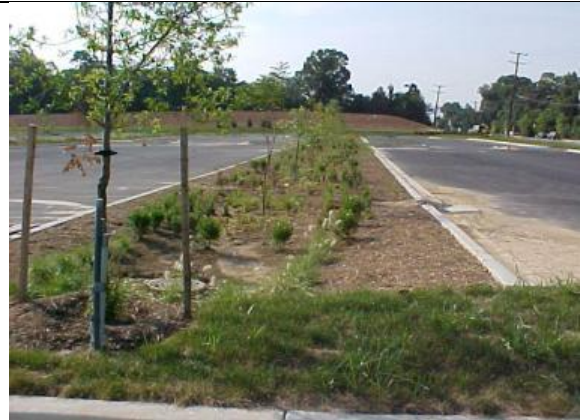
SEVERE

Sediment build-up or staining indicates that water is ponding and a significant amount of runoff is not getting into the facility.

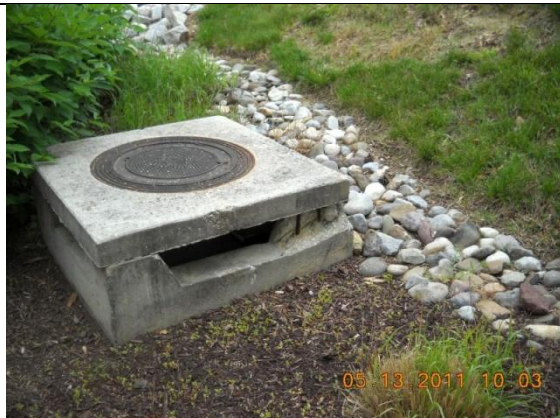
PASS

Inlet (stone channel) in good condition, no evidence of erosion.

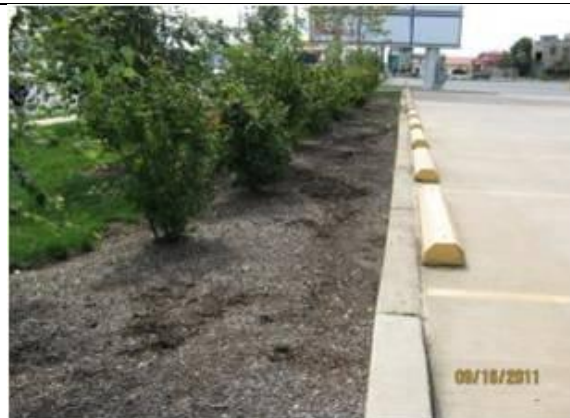
MINOR

Surface runoff from parking lot causing minor erosion of mulch at inlet.

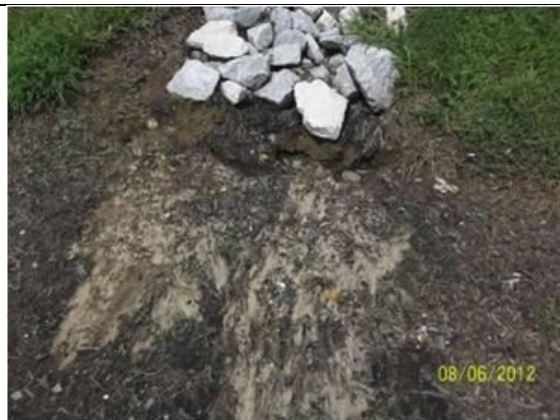
MODERATE

Concentrated flow results in moderate erosion at inlet. Investigation into cause is necessary as could result in more severe condition.

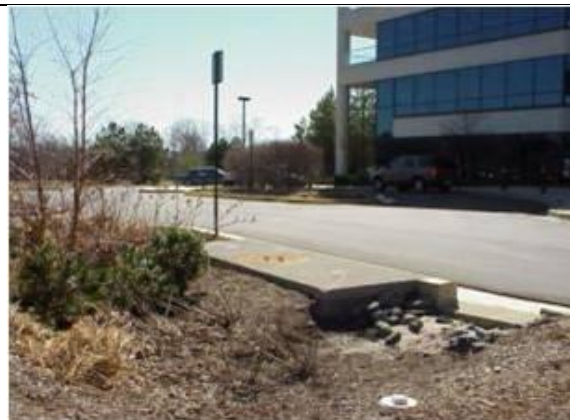
SEVERE

Scour is occurring at the inlet indicates a possible design flaw.

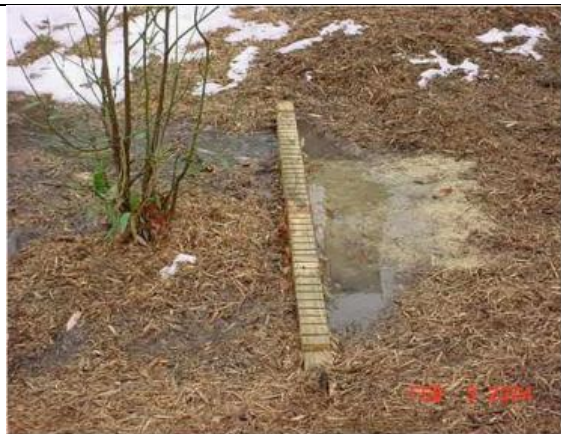
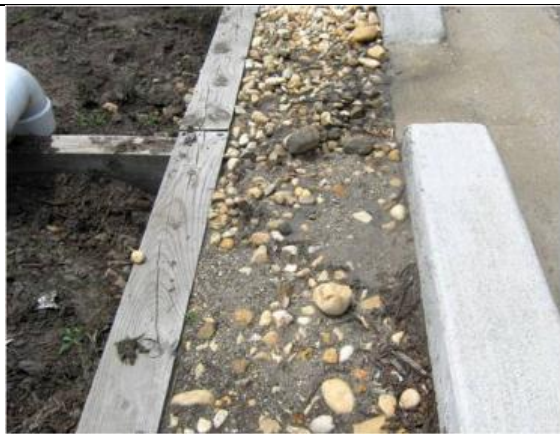
PASS	MINOR

<i>This pretreatment measure is free and clear of sediment/debris.</i>	<i>Slight accumulation of sediment in the pretreatment cell.</i>
MODERATE	SEVERE

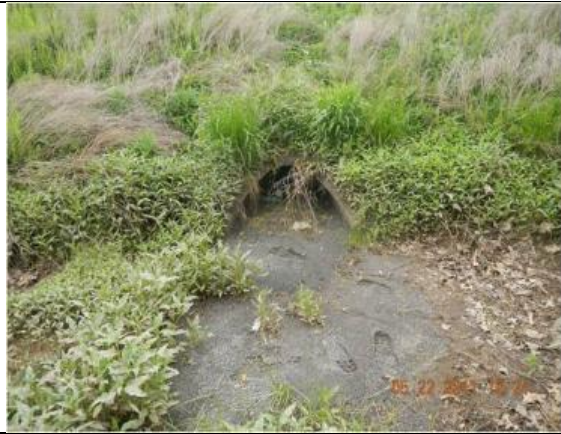
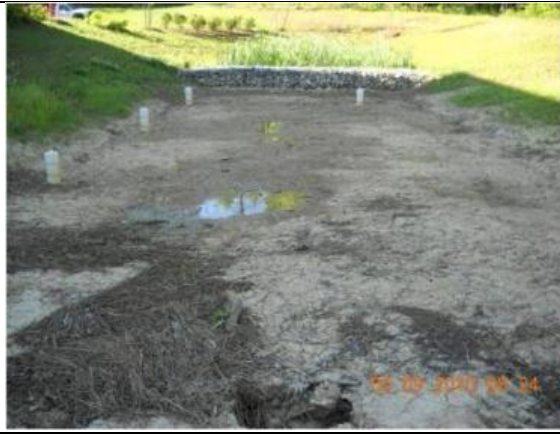
<i>Pretreatment measures needed at this facility. Sediment deposition has almost entirely clogged the inlet.</i>	<i>Lack of pretreatment or inadequate pretreatment has led to facility failure.</i>

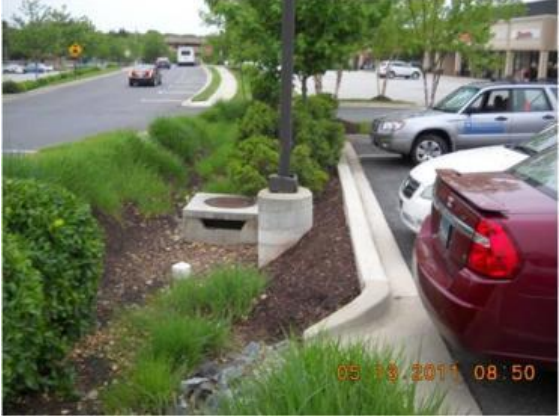
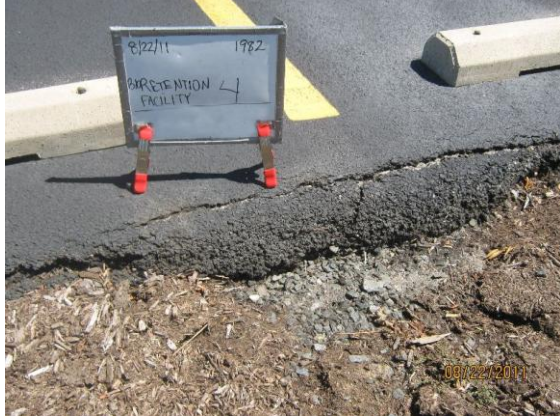
PASS	MINOR

Surrounding curbs and pavement are in good condition.	Some pavement cracking occurring in surrounding pavement.
MODERATE	SEVERE

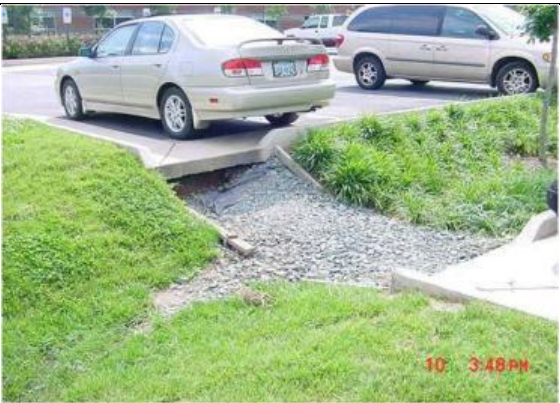
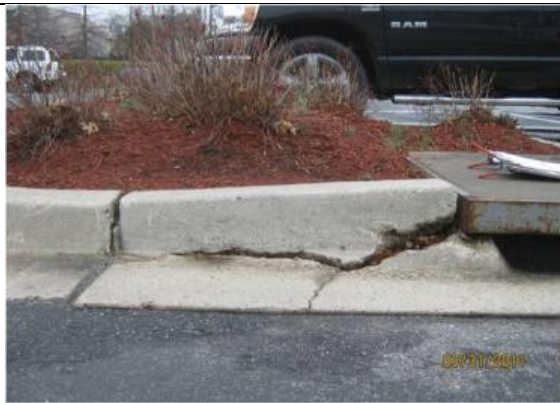
Inlet elevation drop too steep leading to erosion within the facility. Reinforcement needed immediately to prevent collapse.	Major problems with adjacent curbs and/or pavement. Design repair needed.

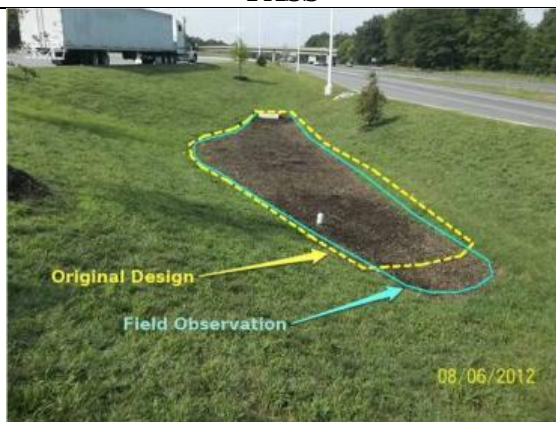
PASS

The surface area of this bioretention facility slightly deviates from the original design but not significantly to impact the pollutant reduction functions of the facility.

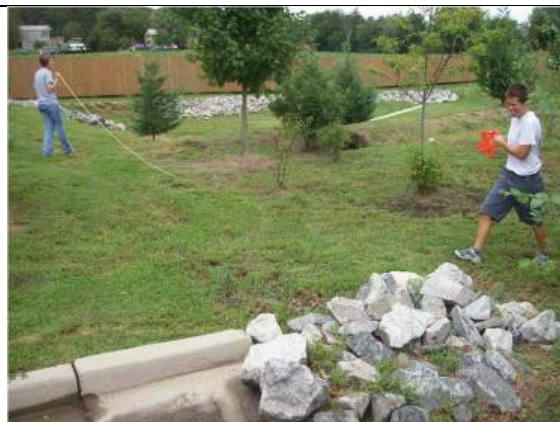
SEVERE

Inspectors measure the surface area of a bioretention facility.

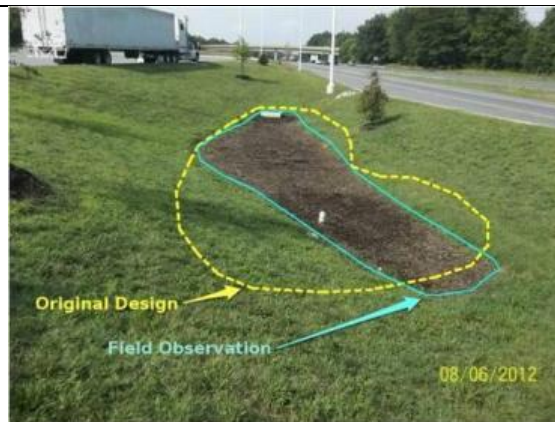
The surface area of this bioretention facility significantly deviates from the original design.

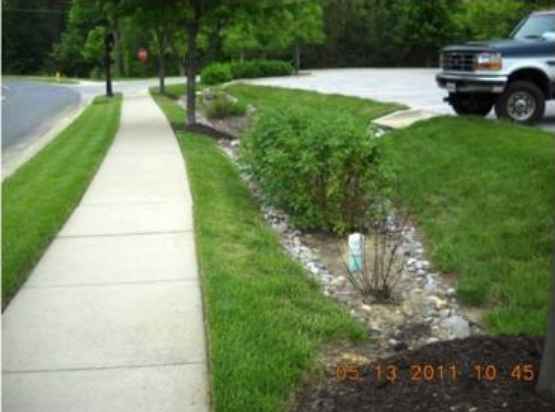
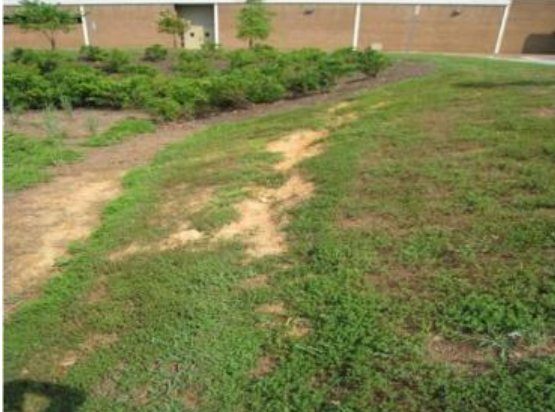
PASS	MINOR

<i>There is no evidence of side slope erosion occurring in this bioretention.</i>	<i>There is minor side slope erosion occurring as a result of overland flow of water into the bioretention facility.</i>
MODERATE	SEVERE

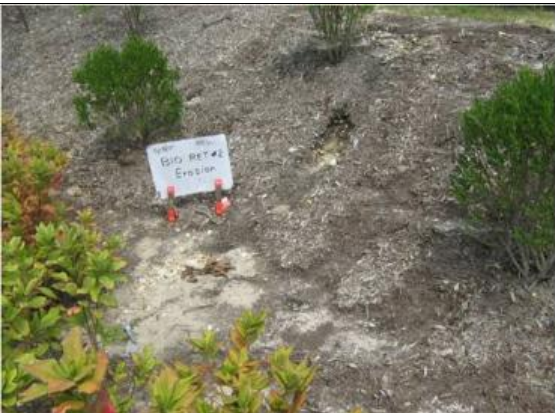
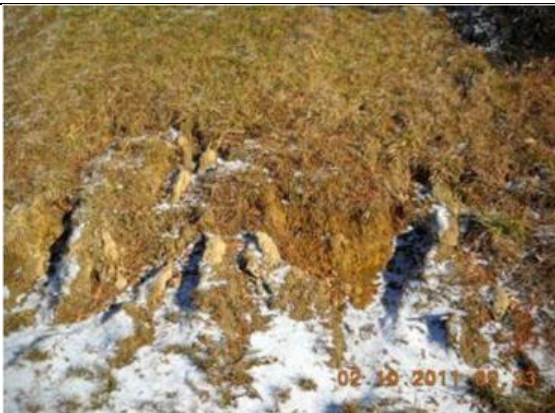
<i>The side slopes in this bioretention are too steep which is causing moderate erosion.</i>	<i>Severe side slope erosion is occurring.</i>

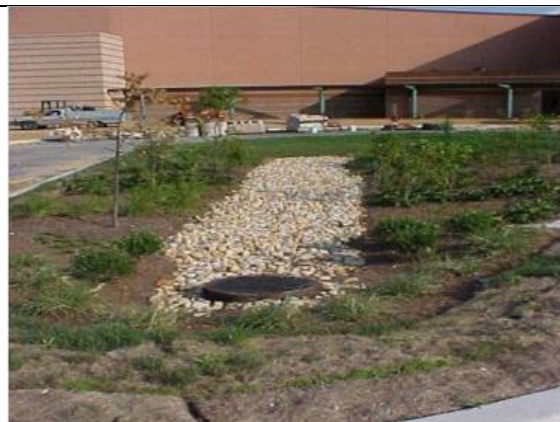
PASS

Runoff spreads evenly through the entire facility and uses the entire ponding depth

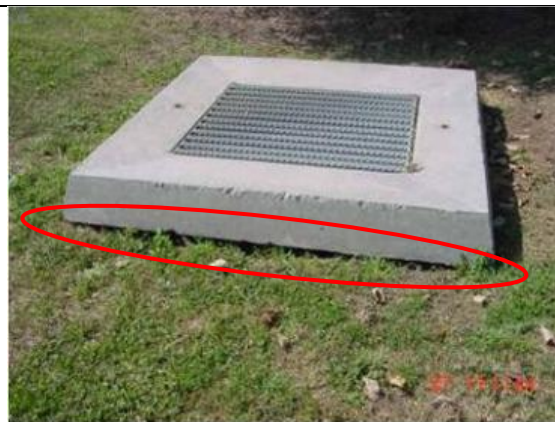
MINOR

Water leaves the facility through the gap at the bottom of the outlet structure before having a chance to fill up the basin.

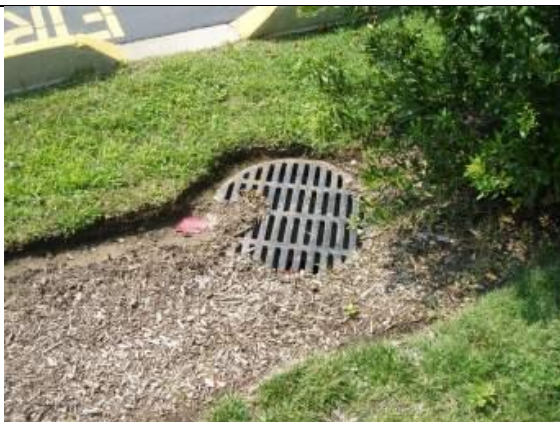
MODERATE

Water that enters the facility leaves before infiltrating into the filter bed.

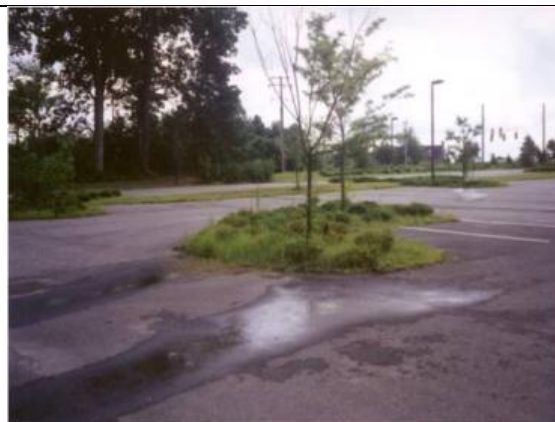
SEVERE

Water is unable to enter the facility due to incorrect elevations.

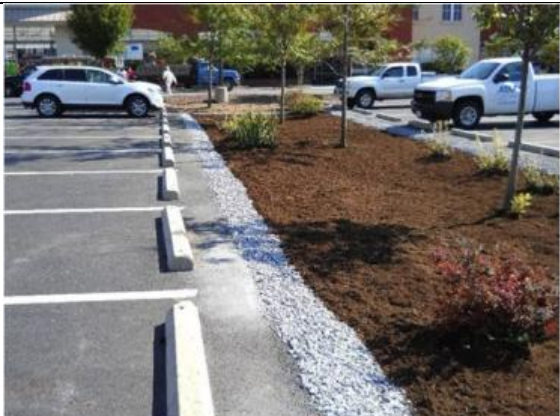
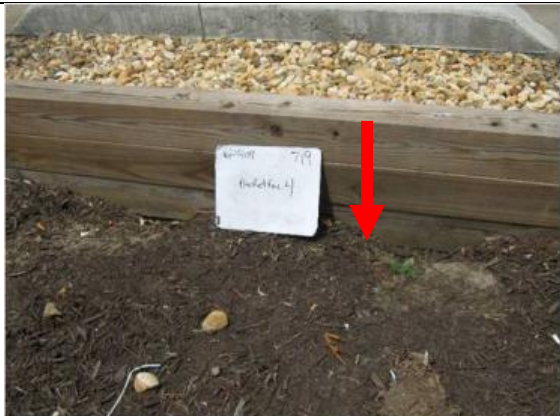
PASS	MINOR

<i>Even, flat bed, with no evidence of sinking</i>	<i>Minor, localized sinking occurring</i>
MODERATE	SEVERE

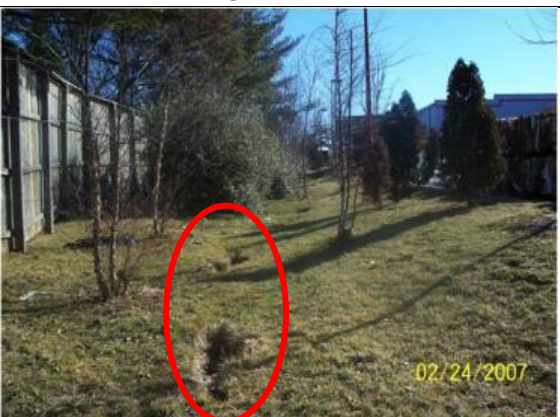
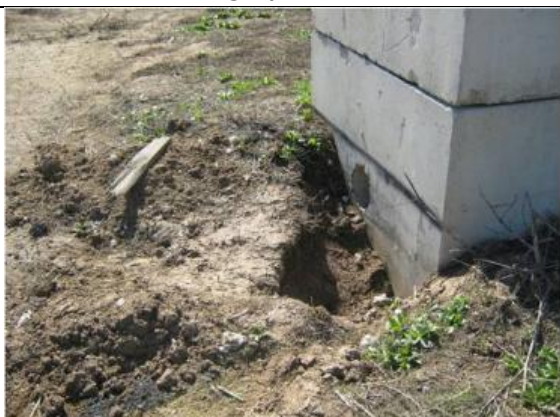
<i>Moderate, localized sinking occurring</i>	<i>Severe sinking occurring at overflow structure.</i>

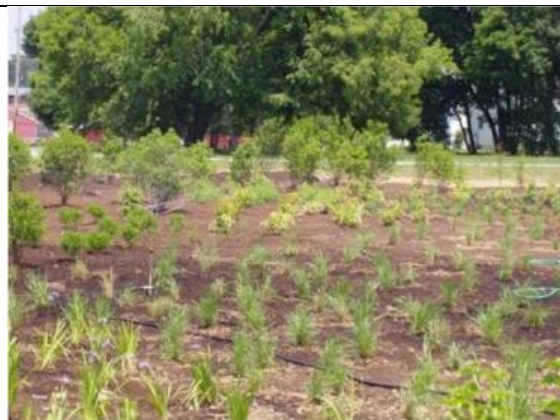
PASS

Bioretention in good condition. Free of sediment and caking.

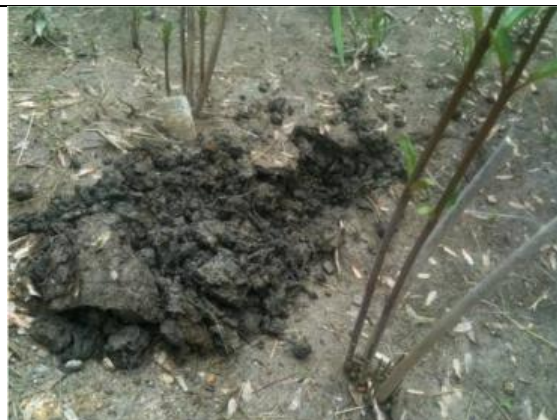
MINOR

Caking occurring on the bioretention bed surface.

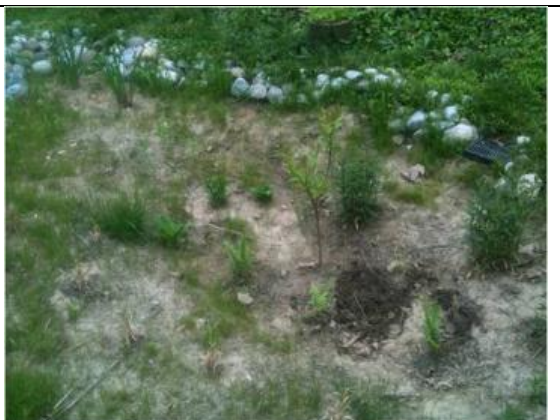
MODERATE

Moderate sedimentation occurring.

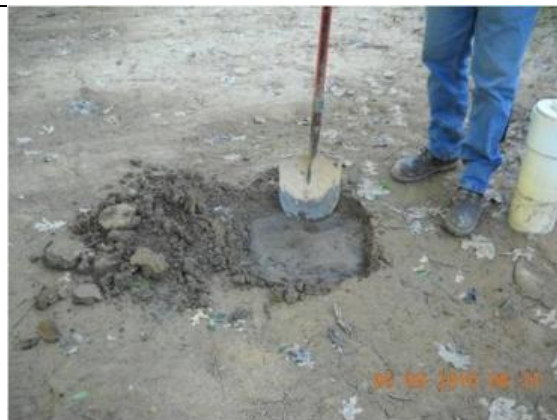
SEVERE

Severe sedimentation occurring; bioretention most likely clogged

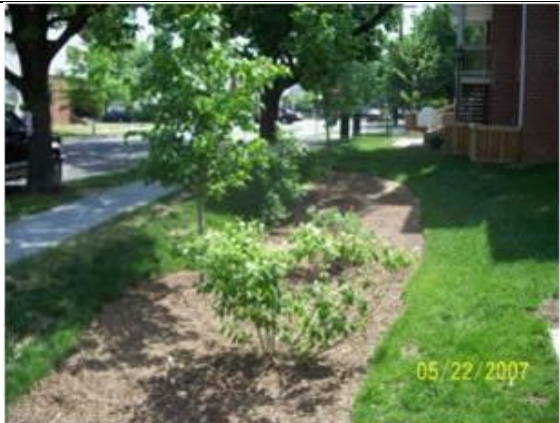
PASS	MINOR

Bioretention in good condition, no evidence of standing water.	Saturated soils indicate presence of standing water.
MODERATE	SEVERE

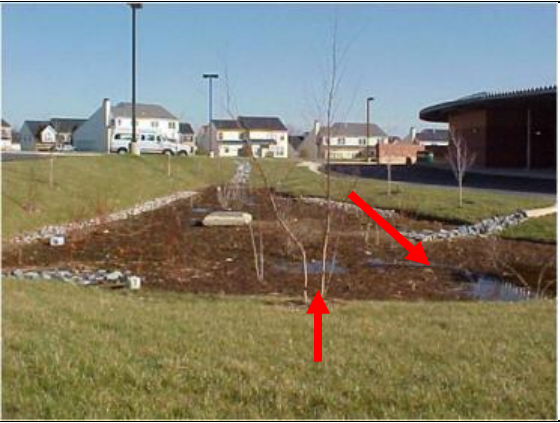
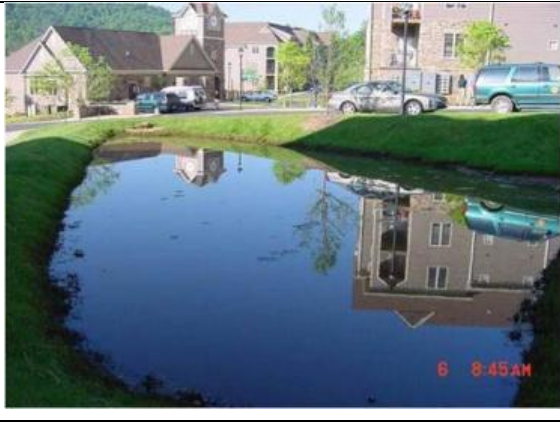
1-3" of standing water after 72 hours	Standing water for more than 72 hours indicates facility failure

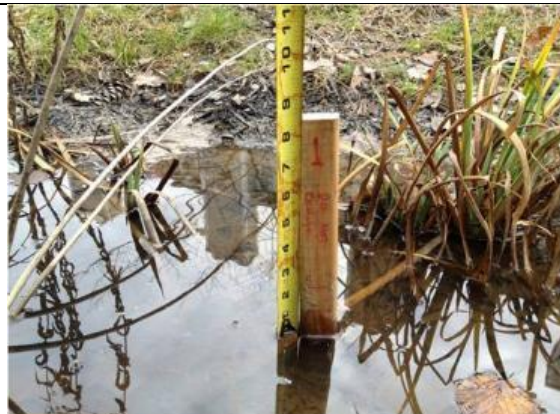
PASS

Ponding depth should be measured and compared to the original design. 6-12" is standard for most bioretention facilities (however ponding depth limits vary by state, check your state stormwater manual for guidance).

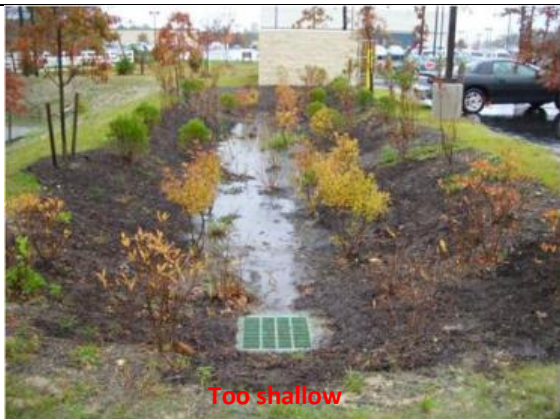
SEVERE

The ponding depth of this facility is significantly shallower than originally designed

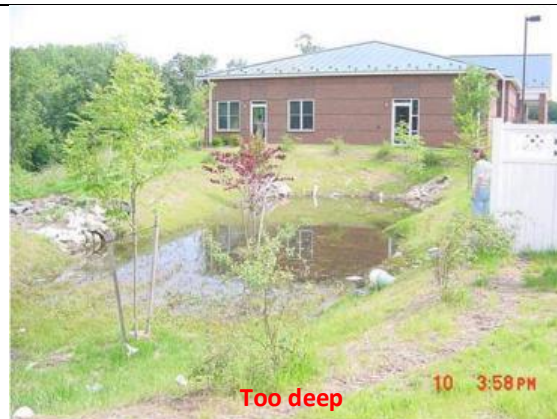
The ponding depth of this facility is significantly deeper than as originally designed

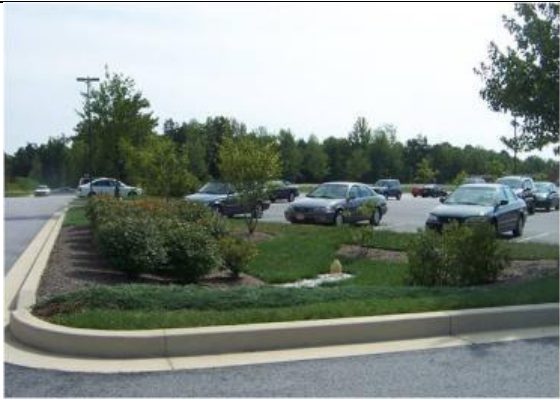
PASS	MINOR

Bioretention in good condition. Good mulch depth and/or ground cover.	Slight displacement occurring. Replace mulch and/or add ground cover.
MODERATE	SEVERE

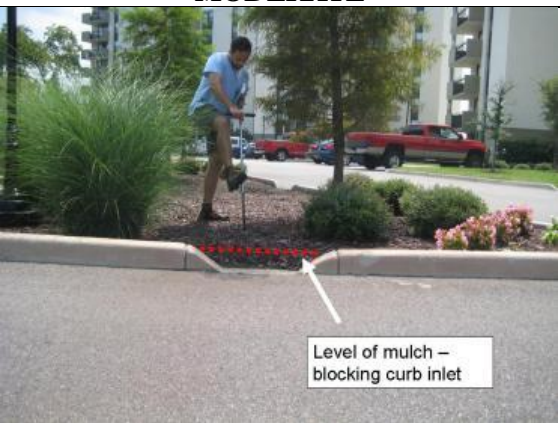
Level of mulch is blocking curb inlet.	10" of mulch indicates maintenance crew not aware of function of facility.
