CSN TECHNICAL BULLETIN

Bioretention Illustrated:

A Visual Guide for Constructing, Inspecting, Maintaining and Verifying the Bioretention Practice

**Version 2.0
July 30, 2013**

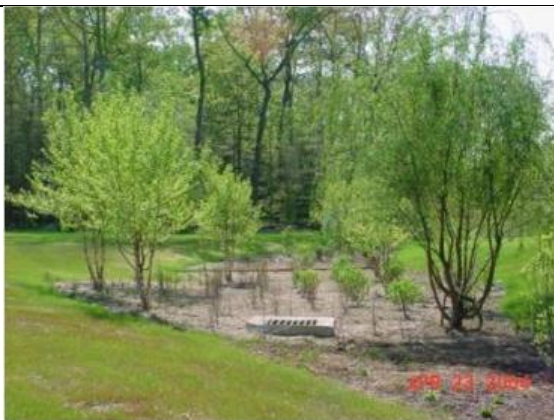
PASS

Bioretention in good condition, no evidence of trash.

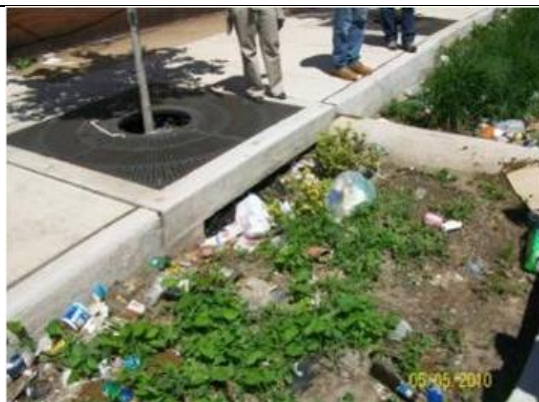
FAIL

Bioretention full of trash and needs to be cleaned out.

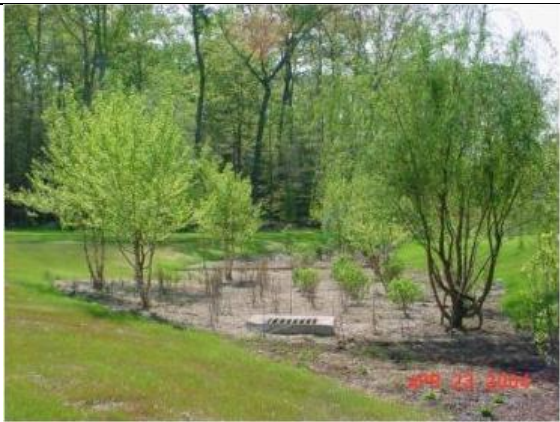
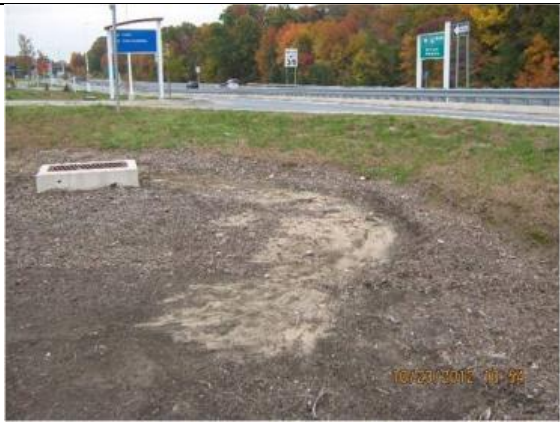
PASS	MINOR

<i>Bioretention in good condition – no bed erosion occurring.</i>	<i>Minor bed erosion or displacement occurring as a result of a larger storm event.</i>
MODERATE	SEVERE

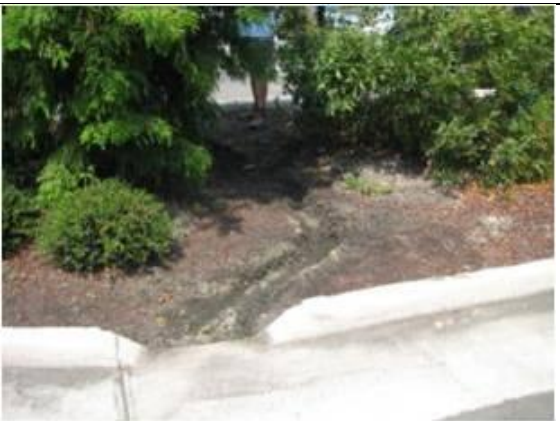
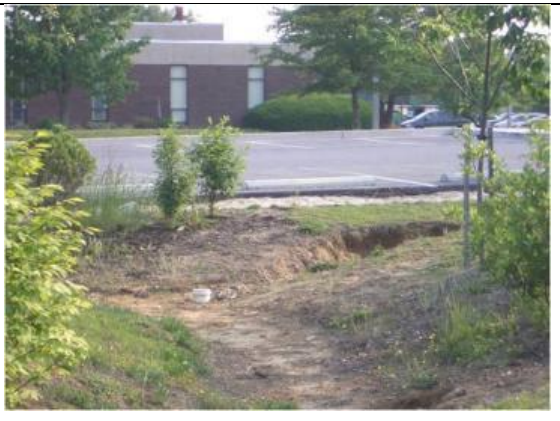
<i>Significant bed erosion occurring leading to a preferential flow path.</i>	<i>Severe bed erosion demonstrates that the bioretention may be undersized for the amount of volume it is receiving or pretreatment is needed</i>

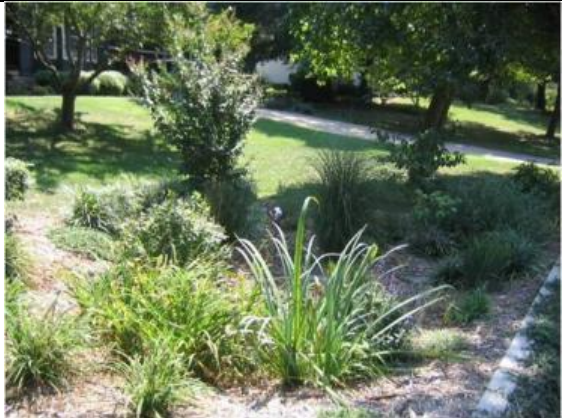
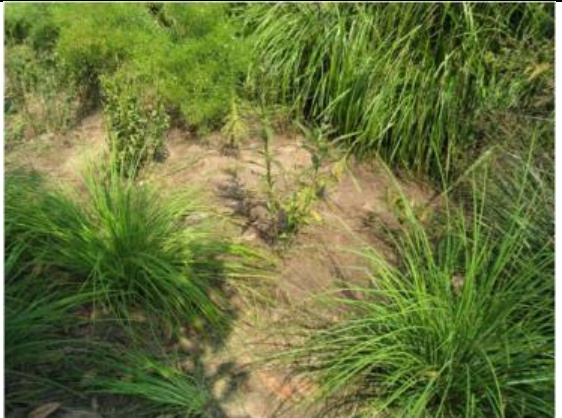
PASS	MINOR

<i>This bioretention has good vegetative cover.</i>	<i>This bioretention has a few bare spots and could use either spot planting or the addition of mulch.</i>
MODERATE	SEVERE

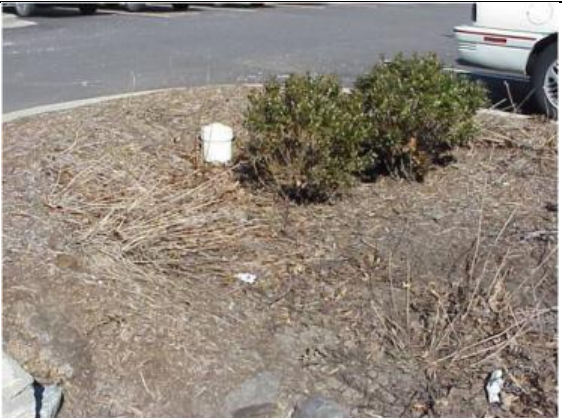
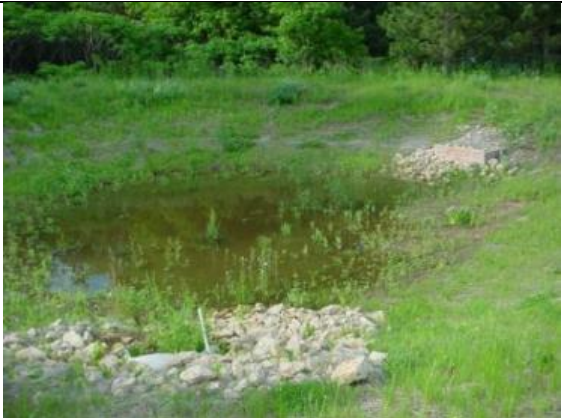
<i>This bioretention has less than 75% vegetative coverage and is probably not functioning to its full potential</i>	<i>Vegetation is not growing in this bioretention as a result of it not being an environment conducive to vegetation or poor maintenance is occurring.</i>

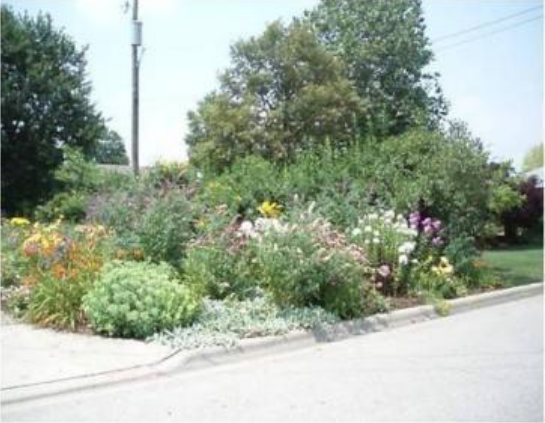
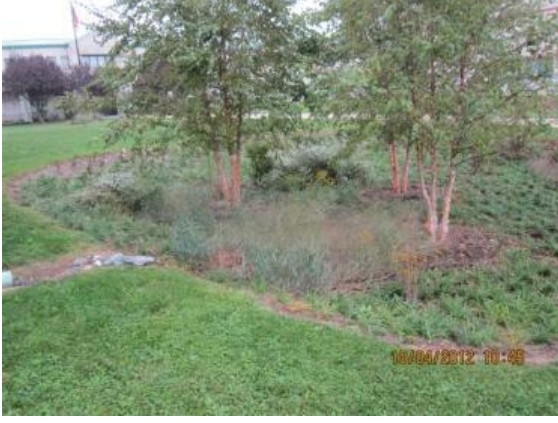
PASS	MINOR

<i>Plants alive and in good condition</i>	<i>Spot weeding needed.</i>
MODERATE	SEVERE

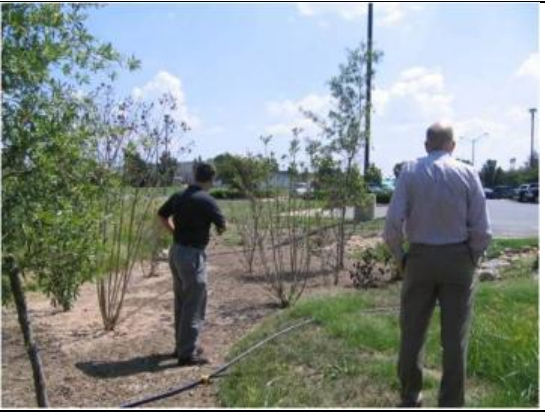
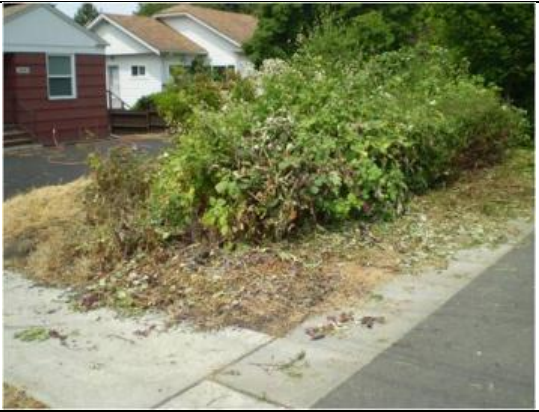
<i>Plants are dead or diseased in this bioretention facility.</i>	<i>This bioretention is overrun with invasive plants.</i>

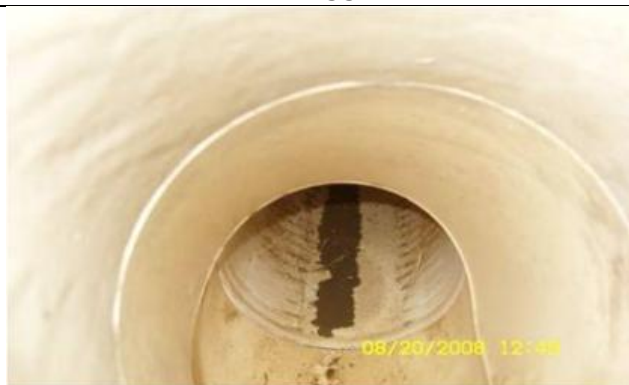
PASS

This underdrain is mainly free of sediment and debris.

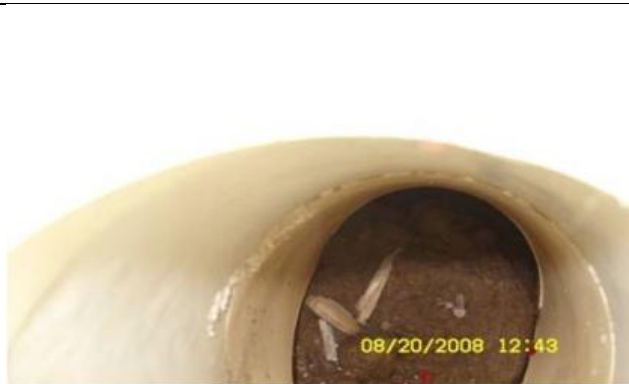
SEVERE

This underdrain is clogged with sediment. Further investigation is needed to determine the cause of the problem.

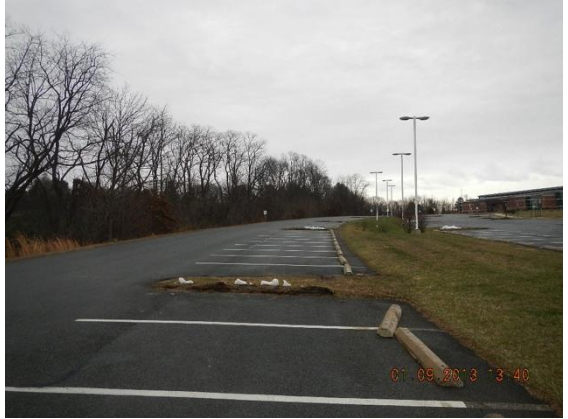
<p><i>Check that the drainage area has not changed.</i></p>
2	Surface Dimensions	Has the width and length of the swale remained the same?

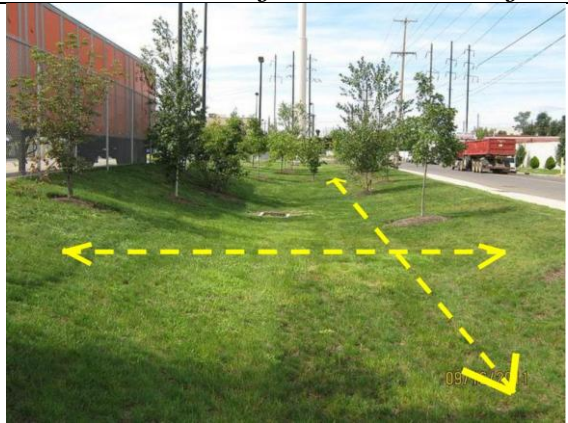
<p><i>Check the size of the facility to see if it has been altered.</i></p>
3	Flow Distribution	Are flows effectively distributed over the width of the swale or is there visual evidence of gully or channel formation?

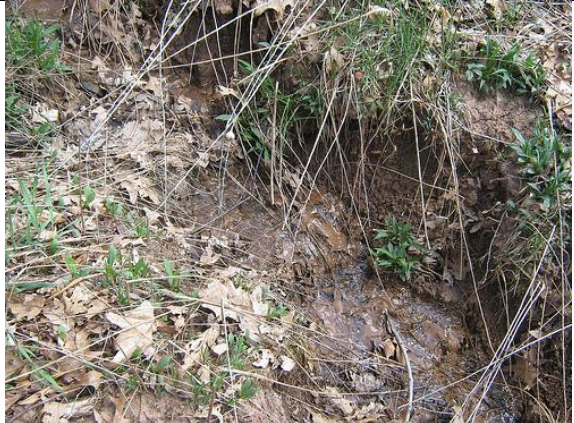
<p><i>Uneven or concentrated flow causes erosion.</i></p>

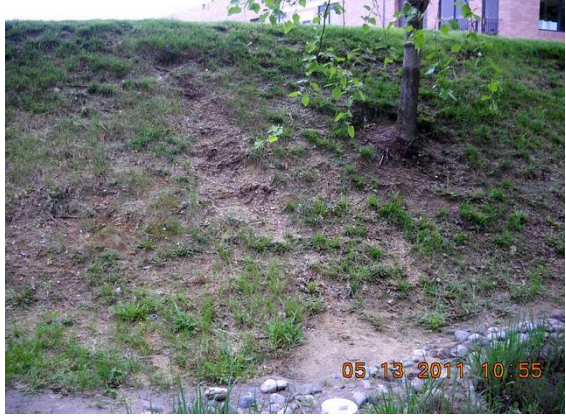
<p><i>Erosion of side slope.</i></p>
11	Vegetative Cover	Does the swale meet numerical targets for turf cover density?

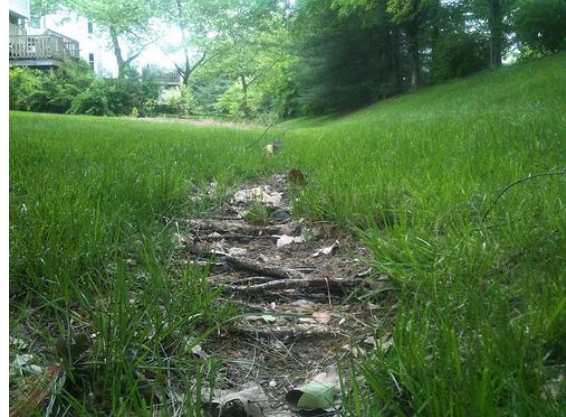
<p><i>Bare area in bottom of facility.</i></p>
12	Vegetative Condition	Is the facility's vegetation in good condition, and is free of weeds?

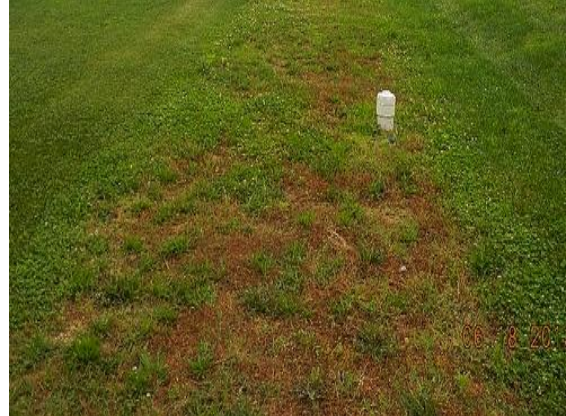
<p><i>Grass in poor condition.</i></p>

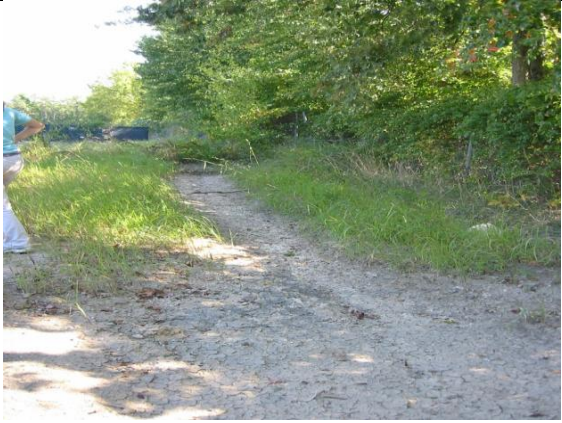
<p><i>Sediment build-up behind check dams.</i></p>
14	Outflow Obstruction	If swale discharges to a storm drain or catch basin, is there evidence of clogging, sediment deposition or erosion?

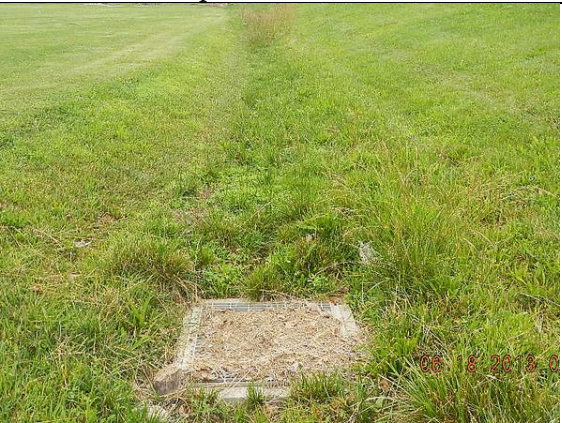
<p><i>Inlet in a grass swale covered by debris.</i></p>
15	Pavement Edge Integrity	Any evidence that the pavement edge is deteriorating or that utilities or other infrastructure are at risk?

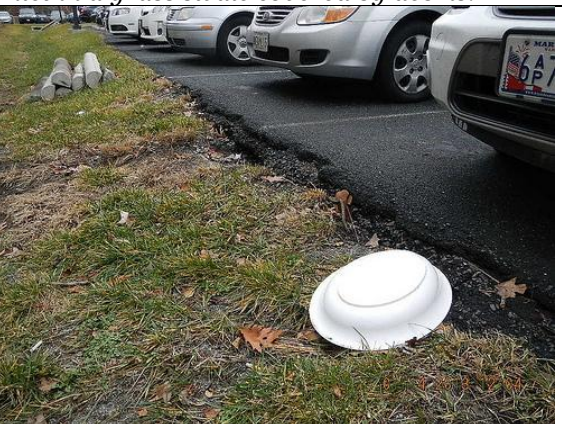
<p><i>Erosion at pavement edge.</i></p>
<p>¹ Both pipe inflow and lateral inflow from road</p> <p>² Does not include wet swales</p> <p>³ Dry swales are inspected using the bioretention VI protocol</p>

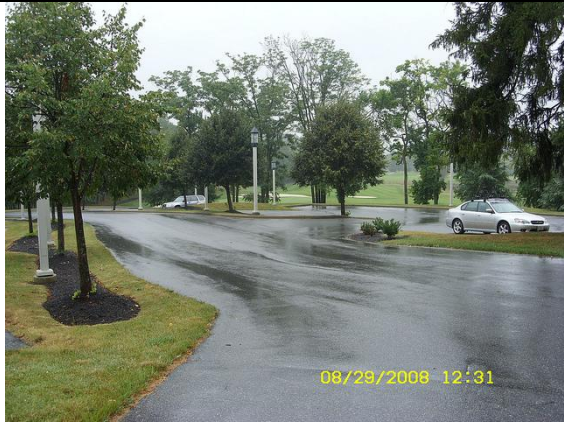
Table B-4 List of Visual Indicators for Filter Strips/Sheet Flow to Buffer			
#	INDICATOR	Description & Rationale	Picture
1	CDA Condition	Has the area or land cover in the CDA materially changed from original design assumptions?

<p><i>A change in drainage area means a change in the volume of water entering a facility.</i></p>
2	Surface Dimensions	Has the width and length of the filter remained the same?

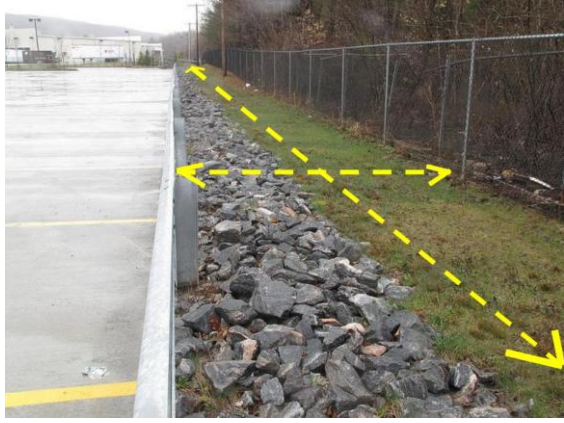
<p><i>Measure the length and width of the facility.</i></p>
3	Flow Distribution	Are flows effectively distributed over the filter width, or is there visual evidence of channel formation?

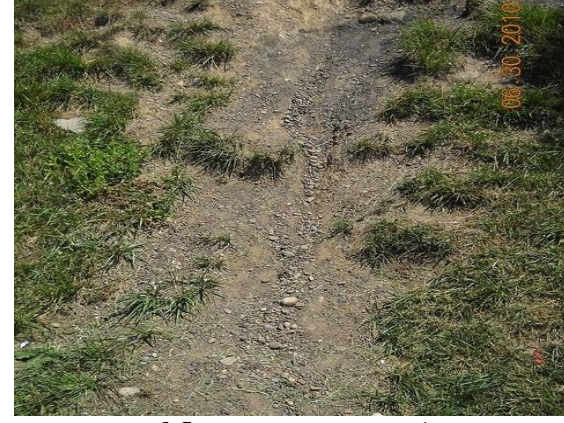
<p><i>Concentrated flows can cause erosion.</i></p>

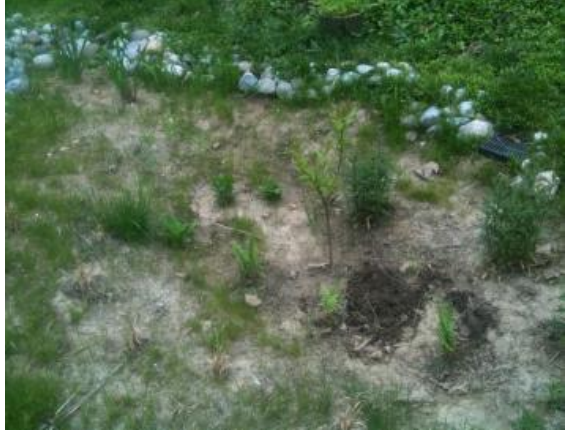
4	Sediment Deposition	Is there evidence of deposition or caking within the filter?

<p><i>Sediment deposition in a facility.</i></p>
5	Saturated Soils	Any evidence of saturation of surface soil days after a storm?

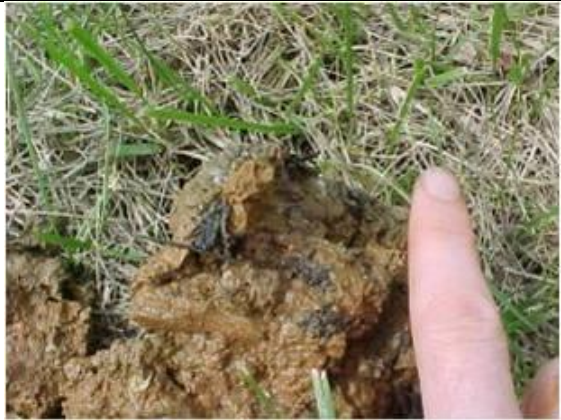
<p><i>Saturated soil days after a storm indicates poor drainage.</i></p>
6	Trash/Dumping	Any evidence of excessive trash/dumping that affects aesthetics or interferes with basic mowing operations?

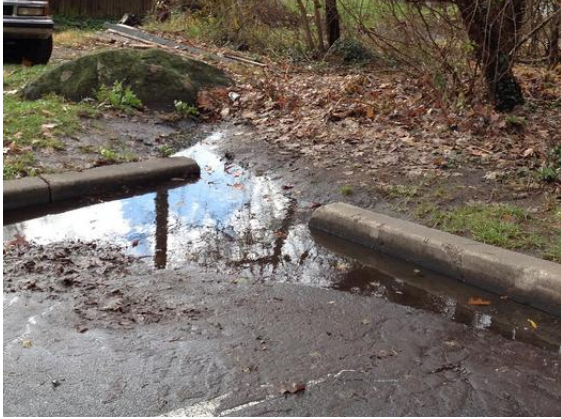
7	Inlet Obstruction	Any evidence that runoff cannot enter the filter strip or level spreader due to sediment/turf buildup?

<p><i>Sediment accumulation at a curb cut inflow.</i></p>
8	Inlet Erosion	Any evidence of outflanking or erosion below the level spreader?

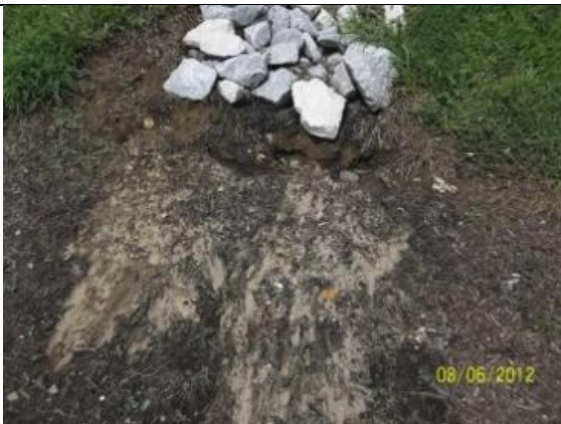
<p><i>Erosion at facility inlet below riprap protection.</i></p>
9	Filter Strip Erosion	Any evidence of concentrated overland flow, and/or rill or gully erosion along the filter strip gradient?

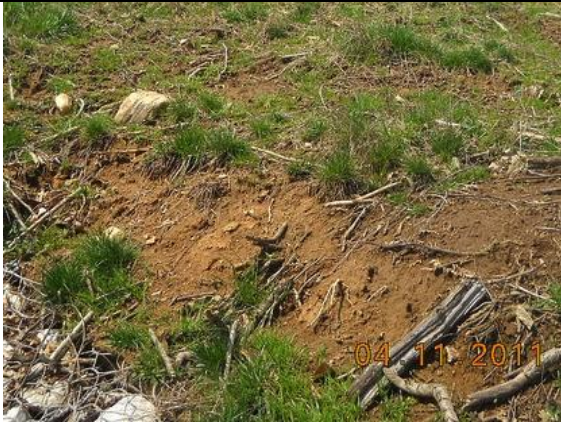
<p><i>Erosion of a slope.</i></p>

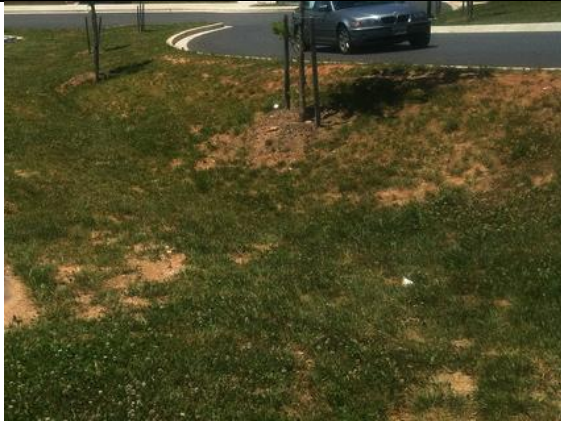
10	Vegetative Cover	Does the filter meet its numerical targets for turf or riparian cover?

<p><i>Erosion can occur wherever there is a lack of vegetative cover.</i></p>
11	Vegetative Condition	Is the filter in good grass or meadow condition and weed- free?

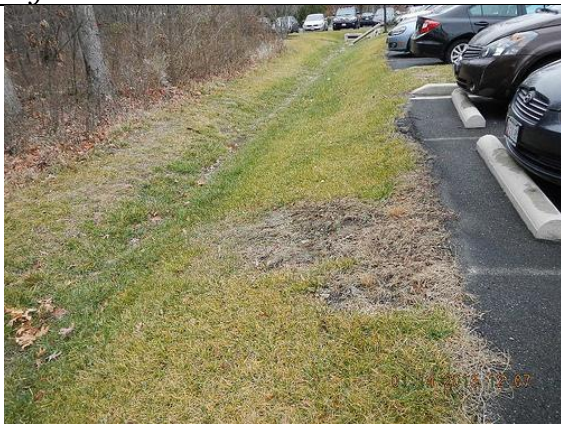
<p><i>Vegetation in poor condition.</i></p>
12	Level Spreaders	Is the structure intact and providing its intended design function? (i.e., no evidence of sediment buildup, hydraulic jump or out-flanking)

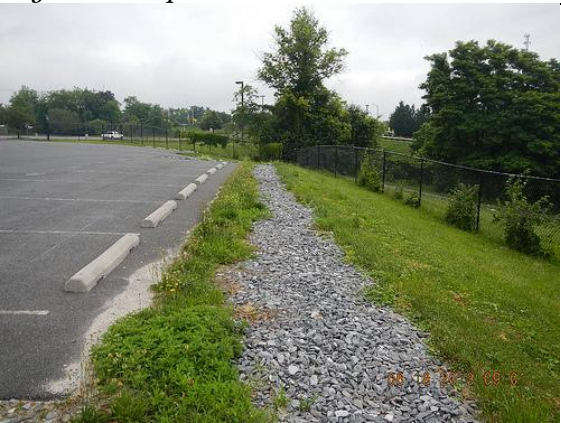
<p><i>Accumulation of sediment along a level spreader. Vegetation is growing in the sediment at the edge of the pavement.</i></p>

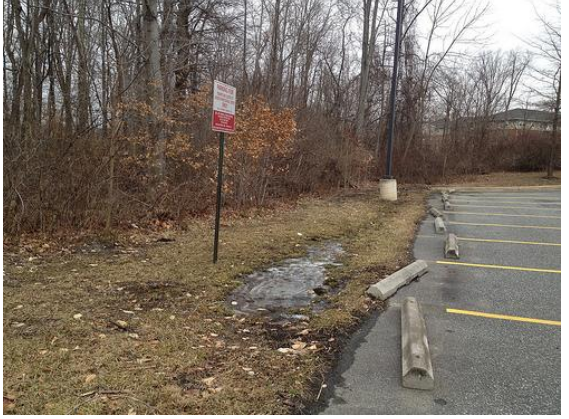
13	Outflow Condition	Does the grass filter effectively transition to a stream buffer or forest?

<p><i>Stormwater first flows through the grass filter strip, and then a strip of forest before reaching the stream.</i></p>
14	Pavement Edge Integrity	Any evidence that the pavement edge is deteriorating or that utilities or other infrastructure are at risk?

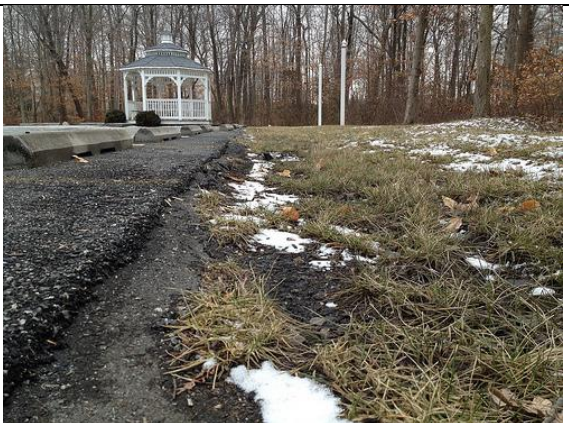
<p><i>Erosion at pavement edge.</i></p>

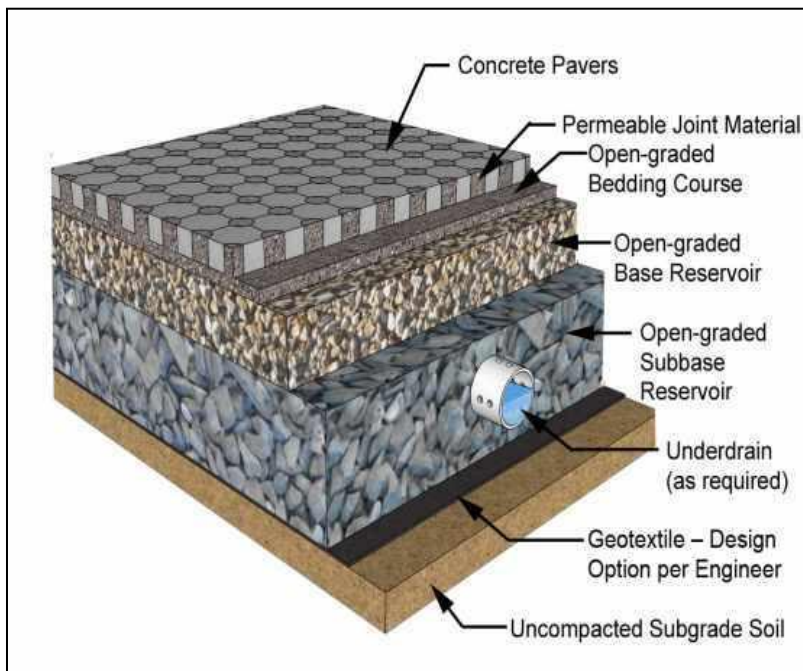
Figure B-5. Schematic Profile for Typical Permeable Pavement Section (Source: David Smith, ICPI).

Permeable pavements are alternative paving surfaces that allow stormwater runoff to filter through voids in the pavement surface into an underlying stone reservoir, where it is temporarily stored and/or infiltrated. Figure B-5 is a schematic of permeable pavement; Figure B-6 is a photo of permeable pavement in good condition.

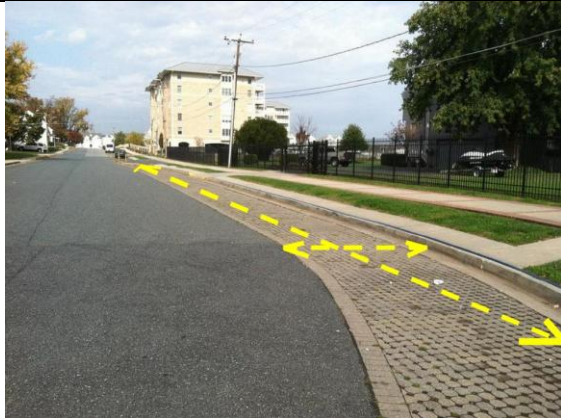
<p><i>Compare the size of the facility with the plans.</i></p>

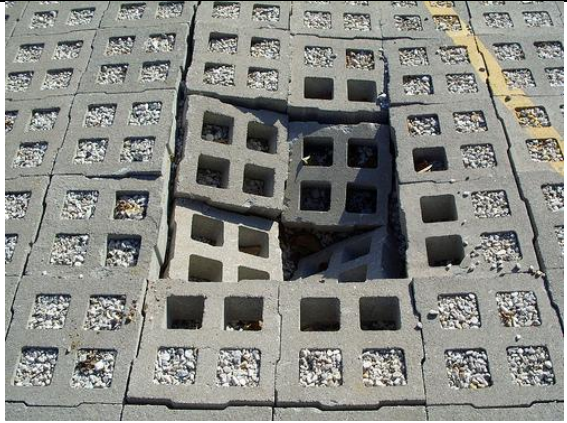
3	Pavement Sinking	Surface should match design slope, with no low points or depressions that promote concentrated inflow or indicate stone reservoir is settling

<p><i>Sunken area in permeable pavement parking lot.</i></p>
4	Surface Clogging	Evidence of sediment or vegetative accumulation on pavement surface or within pavement voids

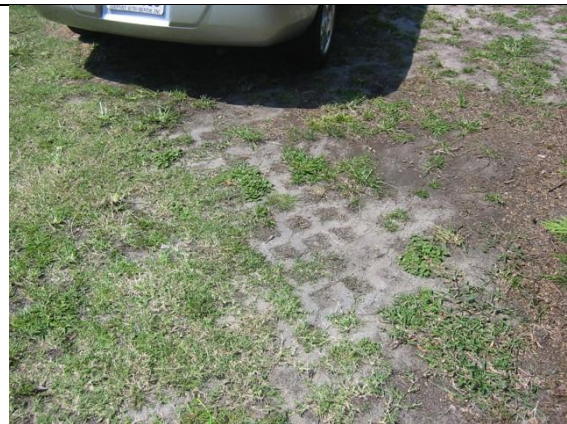
<p><i>Sediment clogging permeable pavement.</i></p>
5	Standing Water	Evidence that stormwater is not getting thru the pavement in all or part of the facility

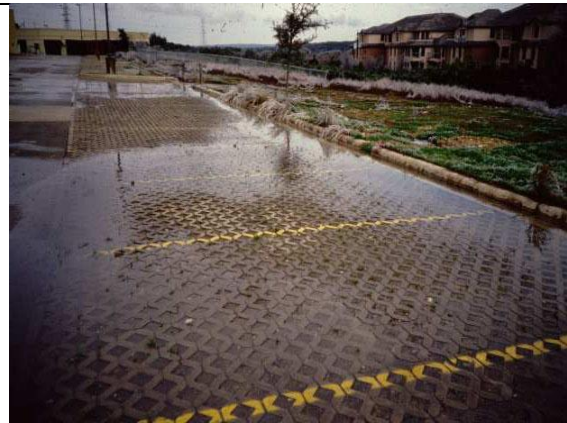
<p><i>There should be no standing water on permeable pavement after a rain event.</i></p>

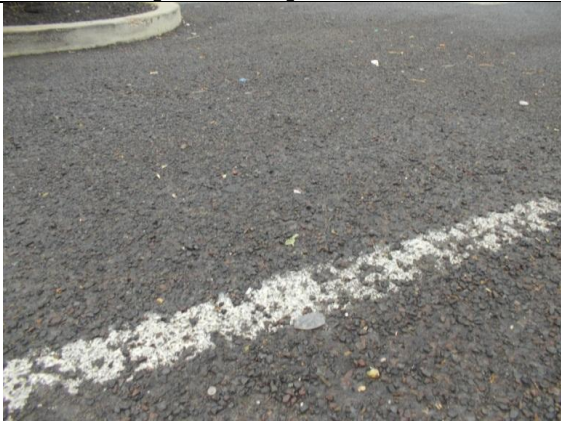
<p><i>Loose gravel on permeable pavement.</i></p>
8	Flow Test	Rapid test to determine whether pavement flow thru is compromised in “at risk” sections of facility

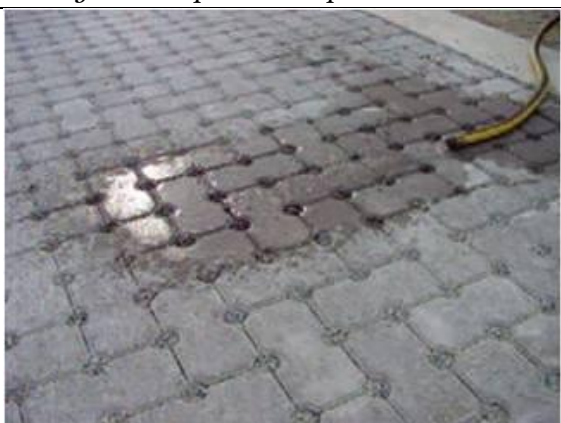
<p><i>A flow test checks for clogging on the surface.</i></p>

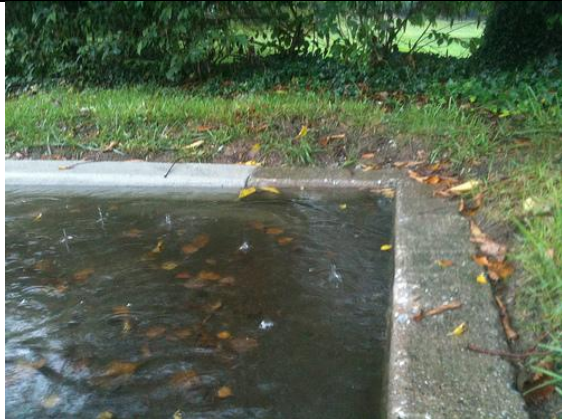
9	Overflow Obstruction	Evidence that runoff from larger storms safely conveys from the facility

<p><i>Flooding due to obstruction of overflow.</i></p>
10	Underdrain or Observation Well	Evidence of sediment or blockage or poor stormwater clearance after a storm

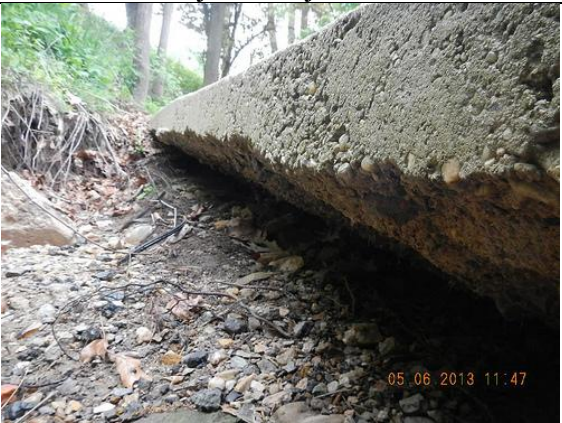
<p><i>Erosion at pavement edge.</i></p>

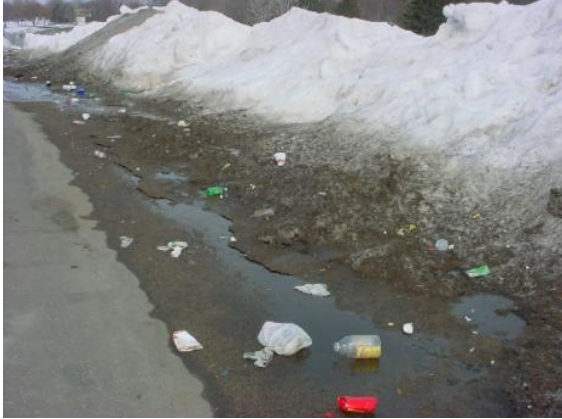
12	Parking Lot Management Practices	Good practices on parking lot and adjacent CDA (no over-size vehicles, no outdoor material storage, leaky dumpsters, proper winter maintenance (no sand or salt), healthy landscaping, leaking dumpsters, etc)

<p><i>Sediment accumulation after snow removal.</i></p>
¹ Applies to pervious concrete, porous asphalt and interlocking pavers

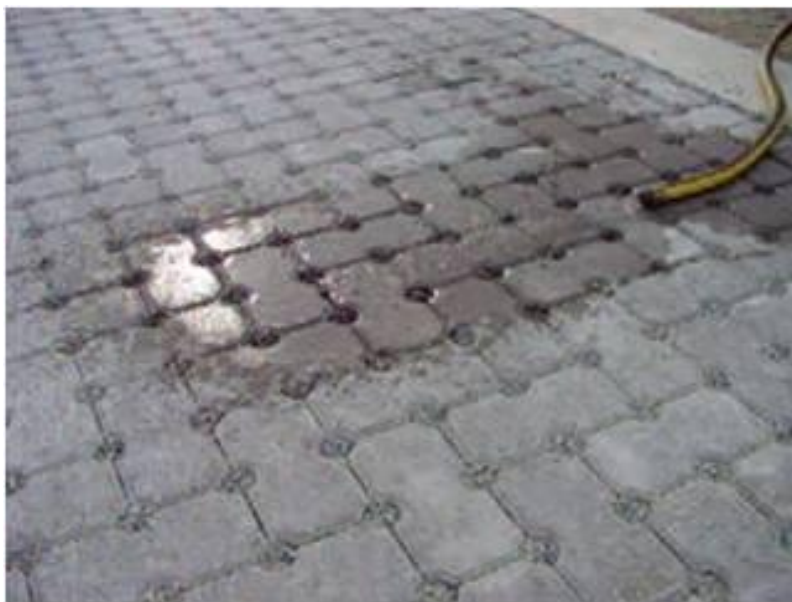
A simple flow through test should be conducted in at-risk pavement sections

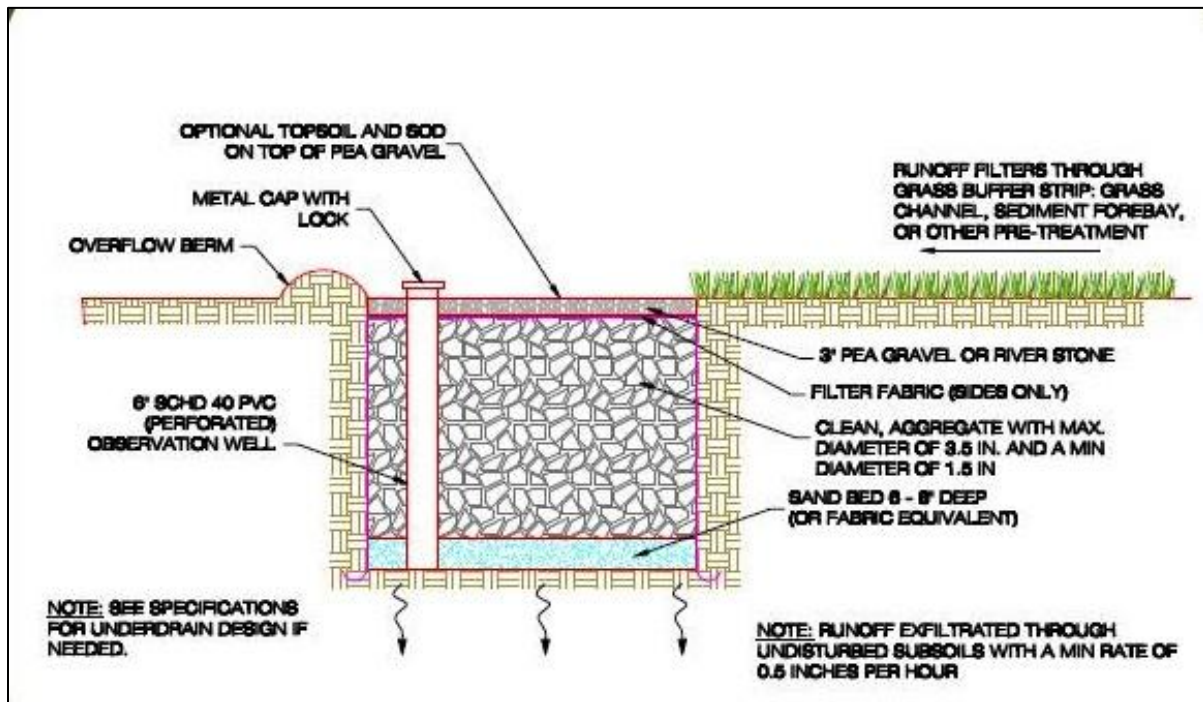
Figure B-7. Schematic of Infiltration Practice

Infiltration practices capture and temporarily store runoff before allowing it to infiltrate into the underlying soil over a period of approximately two days. Figure B-7 is a schematic of an infiltration practice; Figure B-8 is a picture of an infiltration basin in good condition.

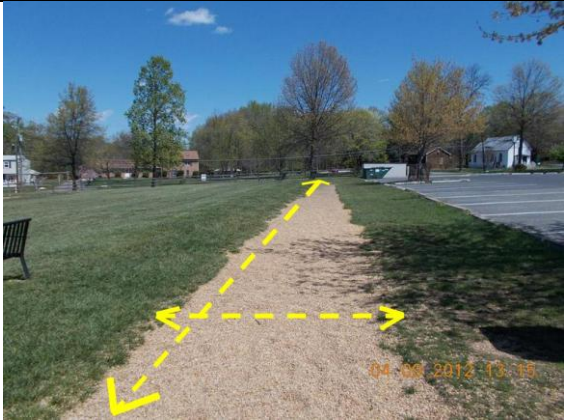
Table B-10 Visual Indicators for Infiltration Practices			
#	INDICATOR	Description and Rationale	Picture
1	Surface Area	Surface dimensions agree with design

<p><i>Check the dimensions of the facility.</i></p>
2	CDA Condition	Stable, no exposed soils, no increase in CDA from design assumptions

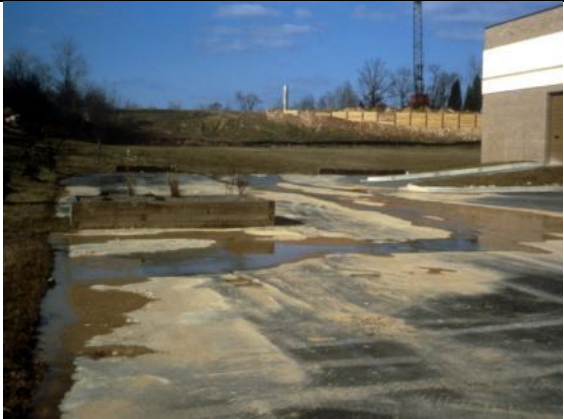
<p><i>The contributing drainage area should be clear of sediment and debris that will compromise the facility.</i></p>

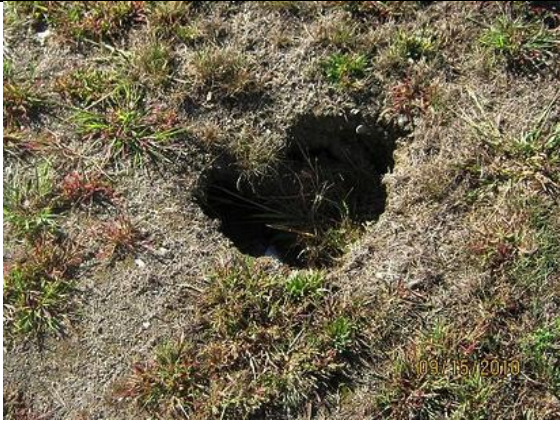
3	Surface Sinking	Surface is not flat, or has low points or depressions, particularly near perimeter edges

<p><i>Sinkhole in a facility.</i></p>
4	Sedimentation or Plant Growth	Sediment or plant growth observed on the surface of the infiltration bed

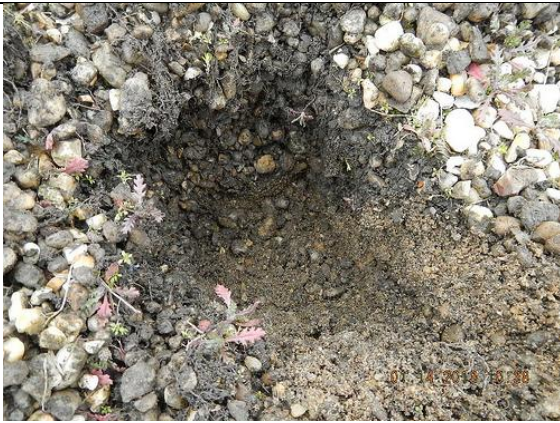
<p><i>Test pit showing sediment accumulation in gravel layer.</i></p>
5	Standing Water	Standing water on surface within 6 hours after a storm

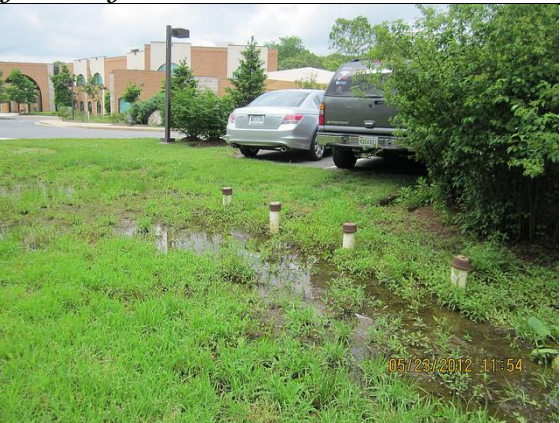
<p><i>Standing water should infiltrate into a facility immediately.</i></p>

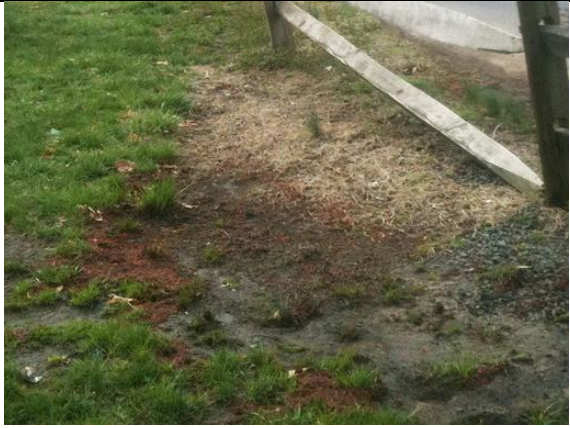
6	Surface Staining	Evidence of hydrocarbon or other staining on surface

<p><i>Stain on surface of a facility.</i></p>
7	Poor Observation Well Measurement	Standing water observed in observation well (OW) after 72 hours of a storm

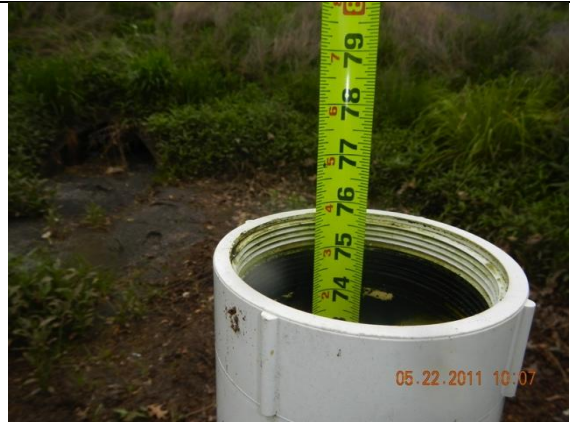
<p><i>Water inside an observation well might indicate poor drainage from a facility.</i></p>
8	Observation Well & Cap	Well and cap are not intact, cannot be opened or allow for measurement of water clearance rate

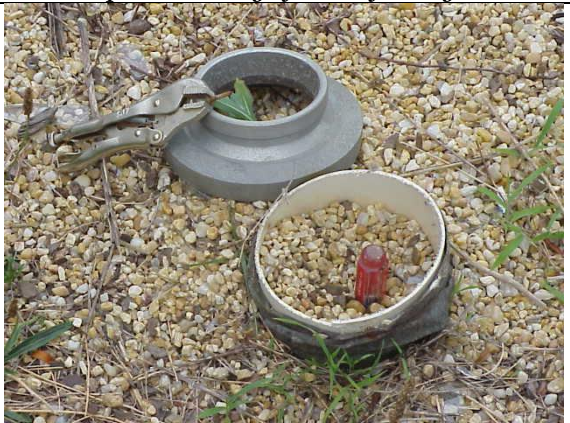
<p><i>Damaged observation well.</i></p>

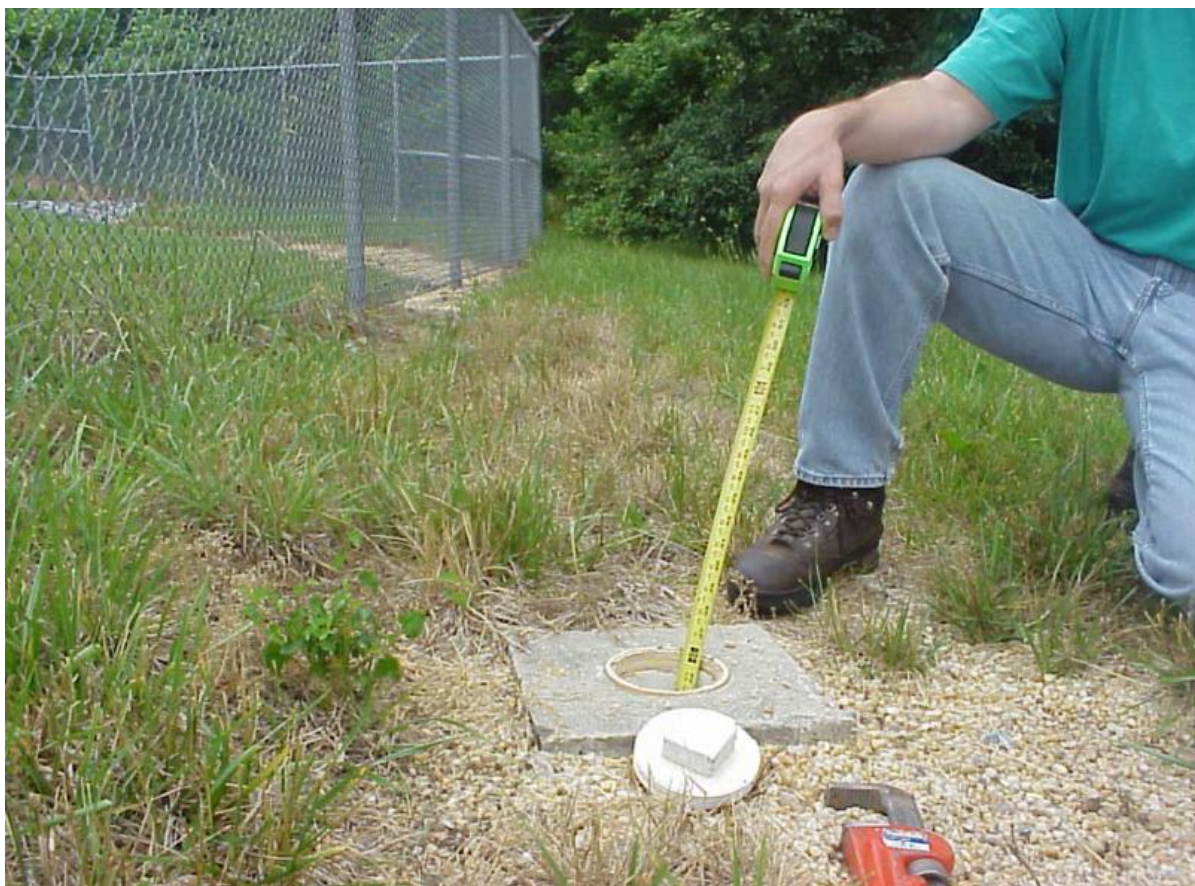
A quick check of the depth of water in the observation well should be done in every inspection
